Master's thesis

**NTNU**  
Norwegian University of  
Science and Technology  
Faculty of Engineering  
Department of Civil and Environmental Engineering

# Track geometry degradation cause identification and trend analysis

May 2019

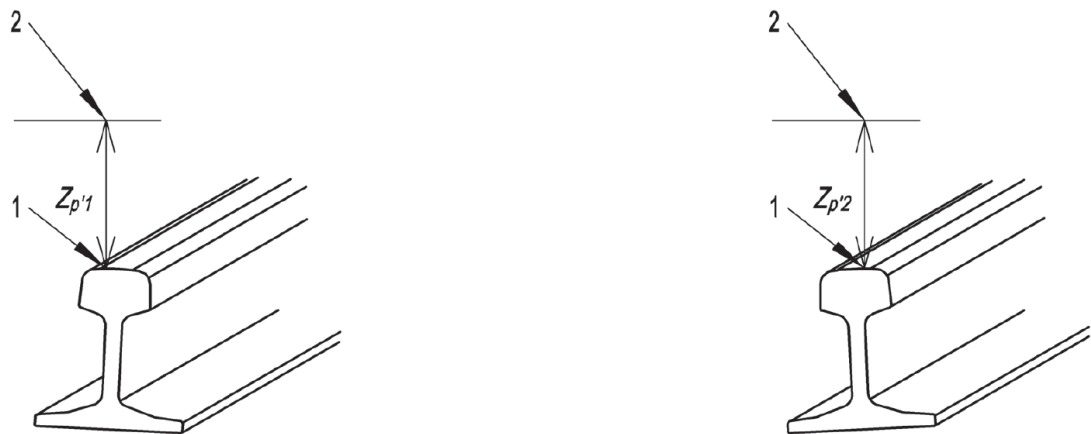
According to EN 13848-1 (European Standard, 2008), longitudinal level is defined as the deviation  $Z_p'$  in z-direction of consecutive running table levels on any rail, expressed as an excursion from the mean vertical position (reference line), and it is calculated from successive measurements. Figure 2-3 illustrates the running table (1) and the reference line (2).

*Figure 2-3 Longitudinal level (European Standard, 2008)*

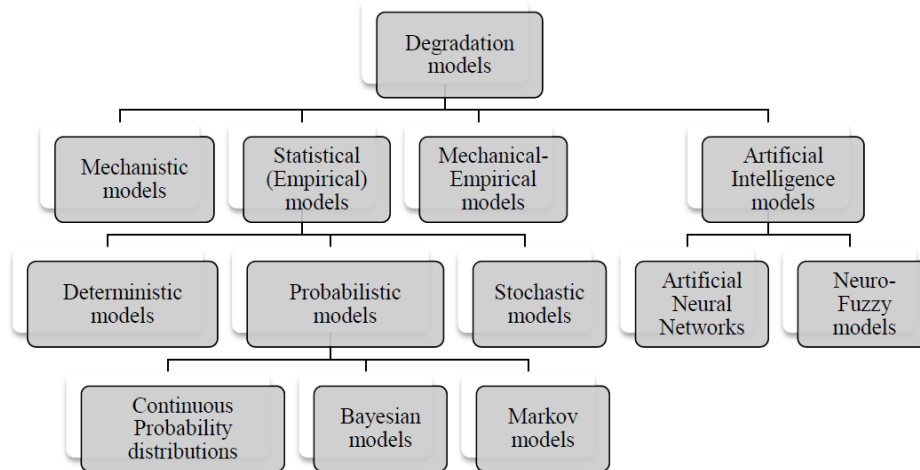
Different degradation models have been developed to predict the future condition of railway tracks, by considering the influencing parameters. The deterioration models can be classified into four general approaches (Elkhoury et al., 2018).

Figure 2-8 Classification of rail degradation models (Elkhoury et al., 2018)

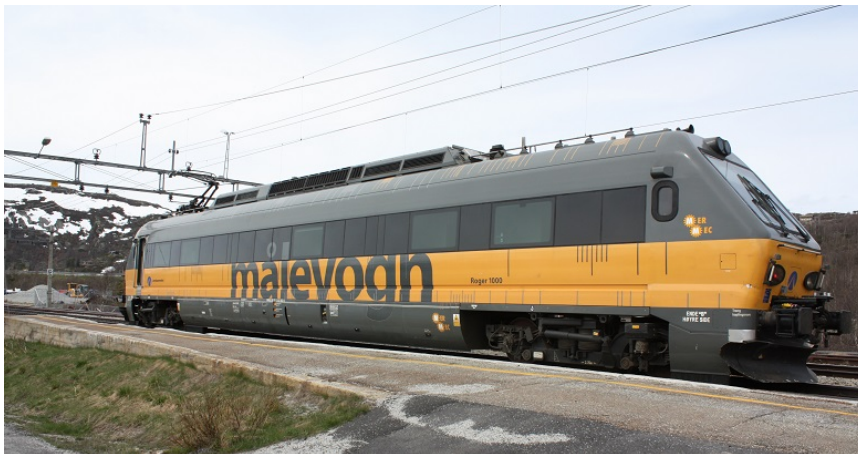
*Figure 3-1 Roger 1000, by Ingunn Halvorsen, 2017*

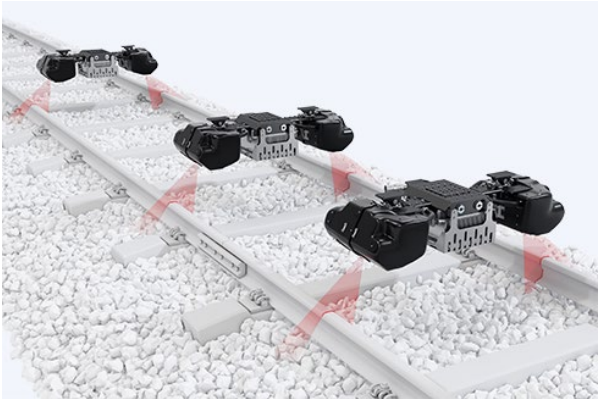
A laser system illuminates the rail as video cameras capture full cross-sectional rail profiles. For Bane NOR's Roger 1000, a total of 20 PCs are used in network for processing, presentation and storage on board.

Figure 3-5 Non-contact optical technology (MERMEC, 2018)

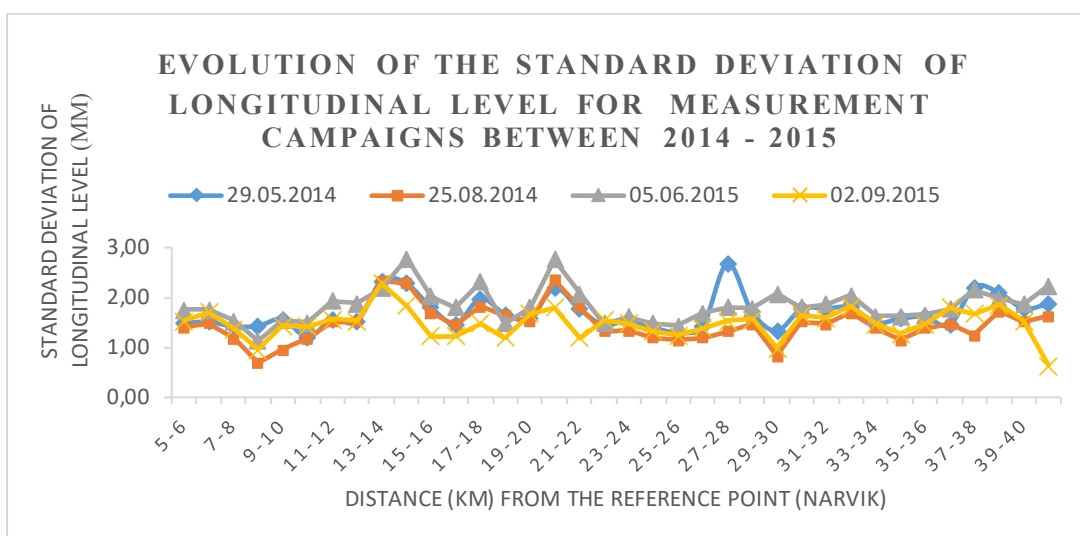
The degradation of track geometry is distinguished by the increase of the standard deviation for longitudinal level defects ( $\sigma_H$ ) for the wavelength range D1 (3 - 25 m), as shown in Figure 4-5 and 4-6.

Figure 4-5 Evolution of standard deviation of longitudinal level between 2014-2015

Figure 4-6 Evolution of standard deviation of longitudinal level between 2017-2018

In Norway, mechanized track maintenance (rail grinding, tamping, ballast cleaning, ballast plough and ballast addition) is commonly carried out after the snow has melted in spring and during the summer. It means that the effect of maintenance is shown on measurements taken in autumn (Figures 4-5 and 4-6). Problems due to frost heave can also give rise to increased standard deviation for longitudinal level ( $\sigma_H$ ) on measurements taken in the spring.

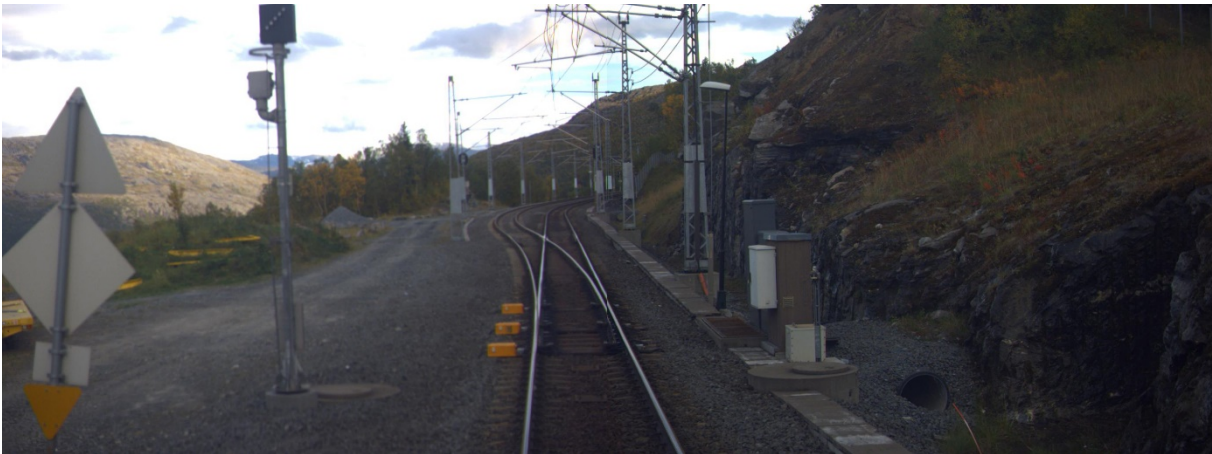
By correlating the track geometry measurement data and video recordings from the external camera mounted on the TRV, one could conclude that the railroad switch gives rise to the increased standard deviation for longitudinal level ( $\sigma_H$ ).

Figure 4-12 Ofoibanen km 13,04 (Bane NOR, 2017)

At switches and turnouts, there is an abrupt change of vertical track stiffness, implying irregular wheel-rail contact forces. Such locations are more prone to develop track settlements due to the permanent deformation of the ballast and the substructure.

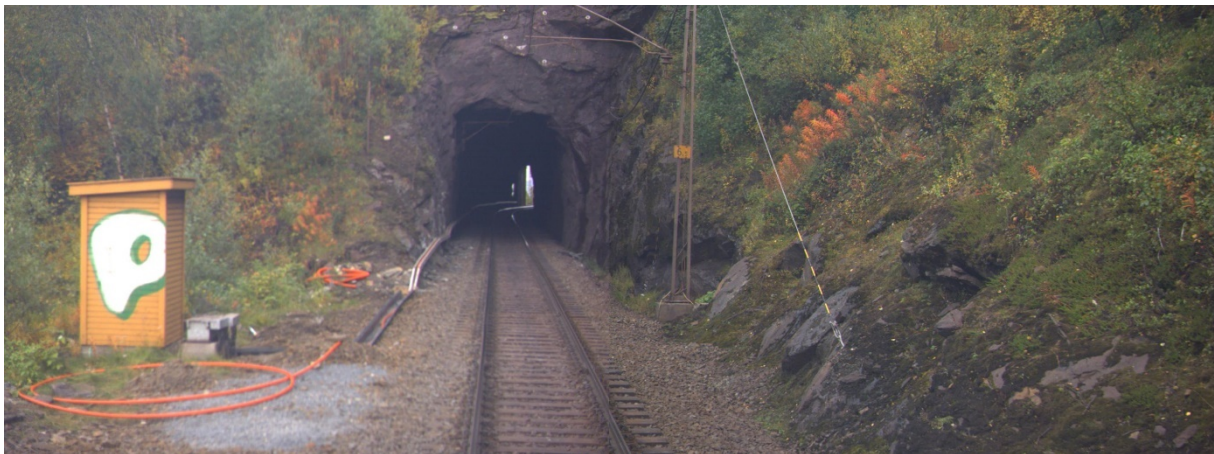
Figure 4-13 Ofoibanen km 6,47 (Bane NOR, 2017)

Figure 4-13 shows a view from the external camera mounted on the TRV at km 6,47, right before the tunnel opening. Old tunnel constructions give rise to increased standard deviation for longitudinal level ( $\sigma_H$ ). This is mainly due to the fact that tunnels on older track sections are not deeper as they should to get sufficient total height up to the tunnel top, and to be able to accommodate a ballast layer under the sleepers, as well as sleepers and rails.

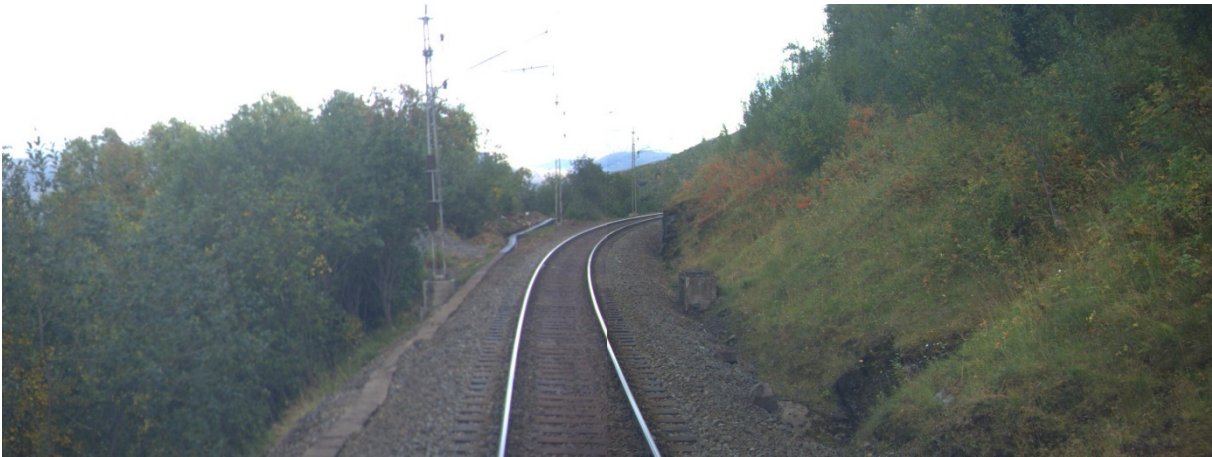
Figure 4-14 Ofofbanen km 9,8 (Bane NOR, 2017)

Records from the external camera mounted on the TRV, between km 9,8 and 10 did not reveal any apparent drainage problems, although the quality limits for standard deviation for longitudinal level ( $\sigma_H$ ) were exceeded. According to Banedata, this is

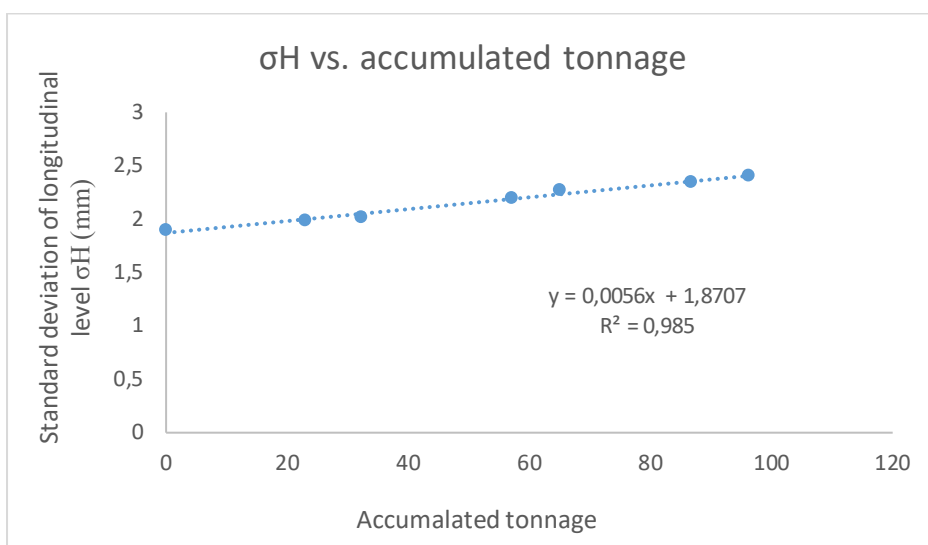
Figure 4-17 shows the linear regression for accumulated tonnage vs.  $\sigma H$ . The  $R^2$  represents the goodness of the model.  $R^2 = 0$  means that the regression line does not fit the data at all.  $R^2 = 1$  means that the regression line fits the data absolutely. The  $R^2 = 0,985$  is a very good fit.

Figure 4-17 Accumulated tonnage vs. sigma H, linear regression, for track segment km 6,0 – 6,2

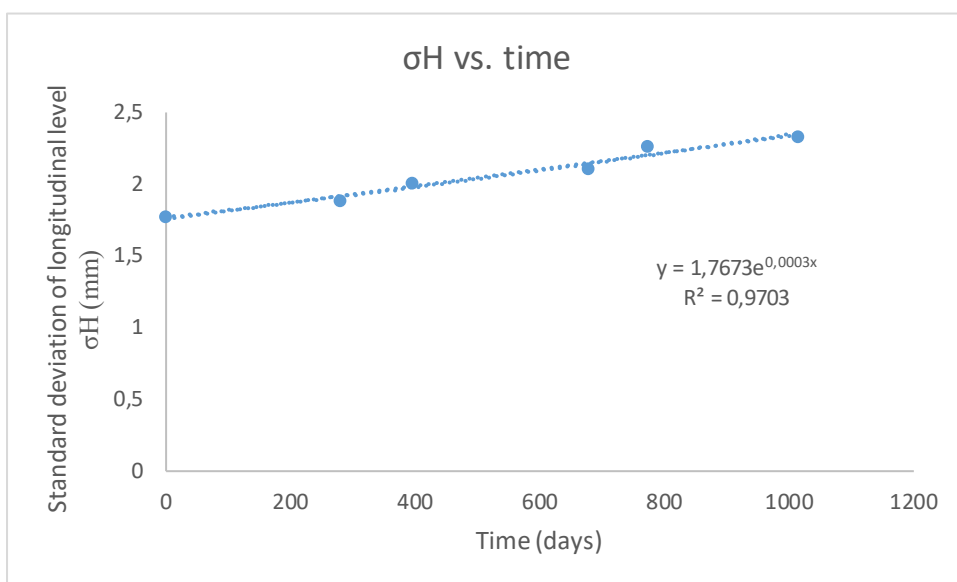
Figure 4-21 Accumulated tonnage vs. sigma H, linear regression, for track segment km 14,4 – 14,6

Figure 4-22 Accumulated tonnage vs. sigma H, exponential regression, for track segment km 14,4 – 14,6

Figure 4-23 Time vs. sigma H, linear regression, for track segment km 14,4 – 14,6

Figure 4-24 Time vs. sigma H, exponential regression, for track segment km 14,4 – 14,6
