Railway Ballast
Characteristics, Selection
Criterion and Performance

NTNU
Norwegian University of
Science and Technology
Thesis for the degree of
Philosophiae Doctor
Faculty of Engineering Science and Technology
Department of Civil and Transport Engineering

Trondheim, September 2014

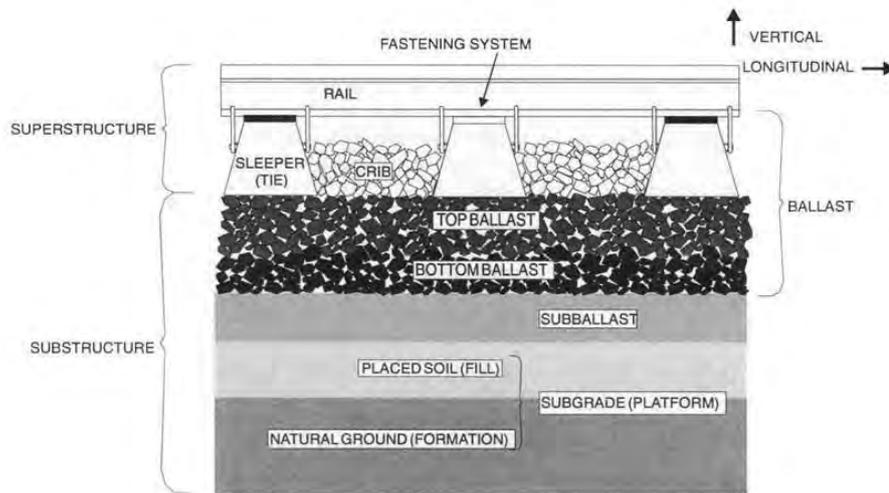
Figure 1.1. Track layout of a typical ballasted track- side view (Selig & Waters 1994).

Freight tonnage, traffic speeds and frequency of trains has been steadily increasing over time worldwide. These changes in traffic characteristics have led to increased wear and shorter lifetime for all track components in superstructure and substructure (Figure 1.1).

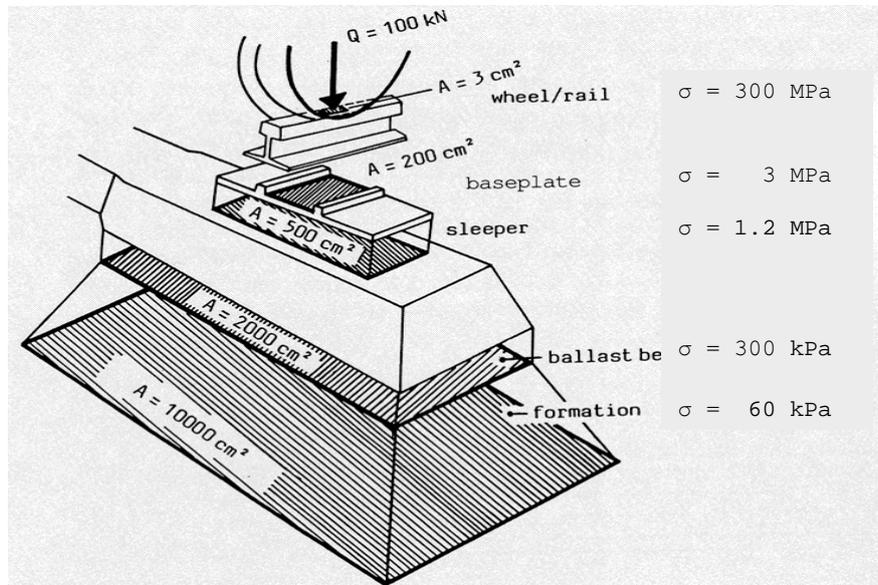
Figure 1.2. Example of pressure distribution from wheel/rail interface down to ballast/subballast interface (modified after Esveld 1989/ Führer 1978).

A very important function for all track components, from rail via sleeper and ballast down to subballast, is to distribute wheel load and contact pressure gradually to successive reduced levels from interface to interface down to the subgrade (embankment or natural ground), see Figure 1.2. The purpose is to avoid ballast breakage, permanent settlements and in worst-case failure in bearing capacity. The figure also shows that the wheel load of 100 kN is distributed with 60 % to the sleeper under the wheel and remaining 40 % to the two neighboring sleepers with about 20 % of each.

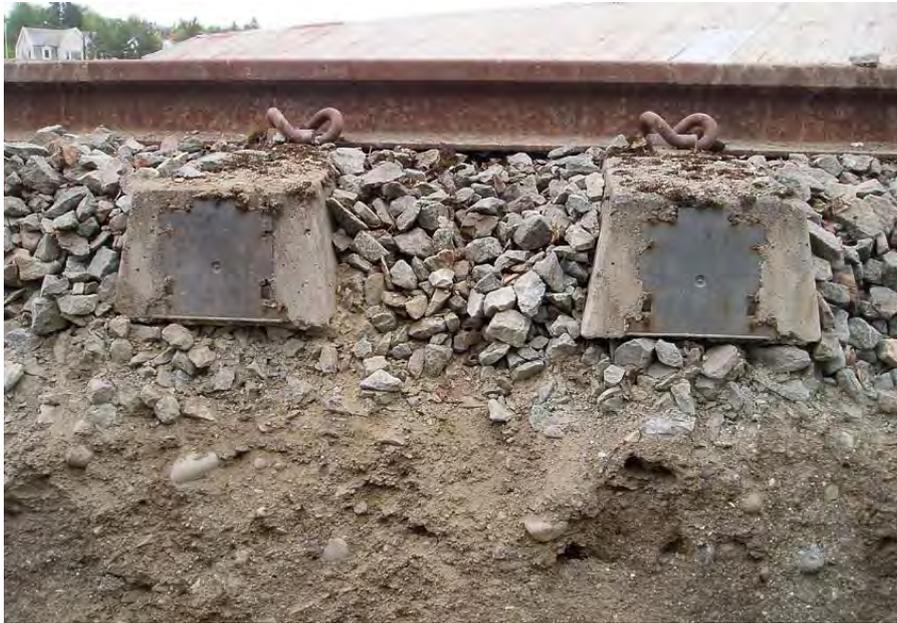
Figure 1.3. Fouled ballast on Stavne-Leangen Line near Trondheim.

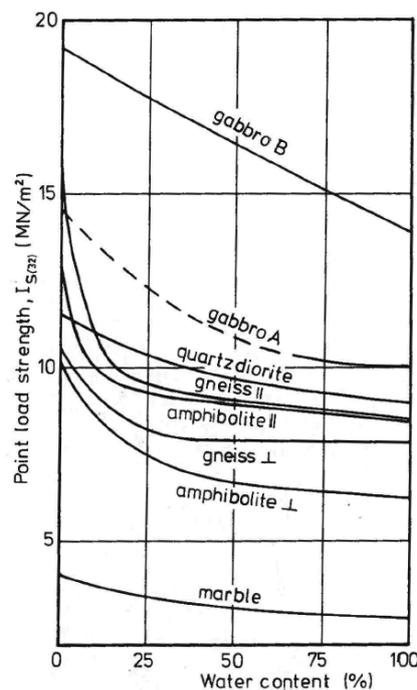
Figure 2.1 Point load strength index ($I_{S(32)}$) as a function of the water content in rock cores (Broch 1974).

Figure 2.1 shows how the tensile strength is dependent on the water content, and that the strength decreases with increasing amount of water. The reduction rate is largest within the range of 0 to 25 % water content. It can also be seen that the loss of strength is much smaller from 75 to 100 %. Hence, for practical reasons the soaking period can be terminated when the water content reaches minimum 75 %.

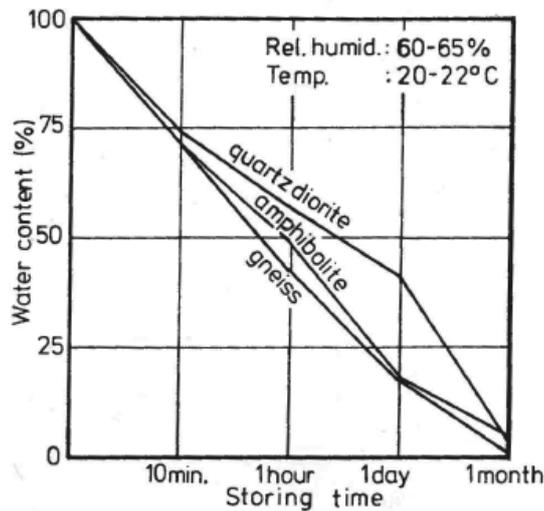
Figure 2.4 Water content in rock cores as a function of storing time in a laboratory environment with relative humidity of 60-65 % and temperature of 20-22 °C (Broch 1974).

Hence, in this project test sample materials prepared for dry state testing (the Los Angeles abrasion test, the Point Load test, the cyclic triaxial test and the full scale rail track model test) were all dried at room temperature. But this procedure requires that the storage time is longer than one day. An investigation conducted by Broch (1974) showed that necessary drying time to obtain 0 % water content is minimum one month (Figure 2.4).

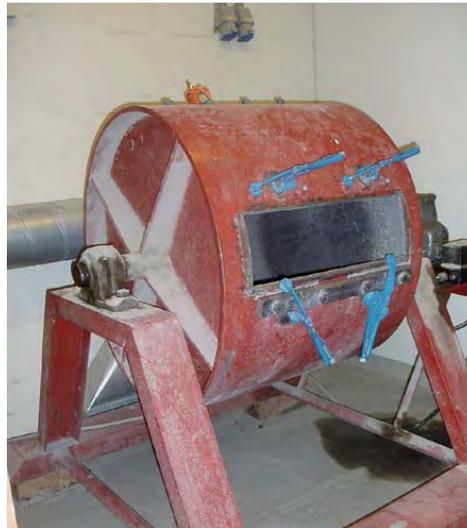
Figure 2.5 The Los Angeles abrasion test drum without cover used for both fraction 10/14 and 31.5/50 mm. Interior diameter is 71 cm.

The classic test for measuring resistance to mechanical breakdown of aggregate is the Los Angeles abrasion test developed in 1916 (Woolf 1937), the most universally used aggregate qualification test throughout the world (Meininger 1994). The test was adopted by the Norwegian National Railway Administration in the 1950's to assess mechanical strength of railway ballast materials. In this study the test has been run according to both NS-EN 1097-2 (fraction 10/14 mm / road materials) and NS-EN 13450 (fraction 31.5 /50 mm / railway materials) which both are performed dry. Figure 2.5 shows the steel drum used for both fractions. The inside diameter is 71 cm and the drum rotates around the horizontal axis. The sample amount for fraction 10/14 mm is 5000 g. It is exposed to 500 revolutions together with 11 steel balls (charges). The corresponding data for fraction 31.5/50 mm is 10000 g, 1000 revolutions and 12 steel balls. A steel shelf within the drum, mounted parallel to the axis, lifts and drops the ballast sample. The tumbling action and the impacts from the charges cause the more brittle particles to shatter, in addition to surface wear and abrasion as the particles rub against one another and against the steel charges.

To reveal how the samples' mechanical strength respond on water, a modified procedure with 3 litres of water added to the drum when testing fraction 31.5/50 mm was performed. Wet state also included that the material was soaked in water for 7 days before test. Wet test of fraction 10/14 mm was not included in this investigation. After the test the crushed material was washed and sieved through a 1.6 mm sieve. The dry weight of the material passing the sieve relative to the total weight expresses the Los Angeles abrasion value. According to standard procedure only one analysis is required per each material.

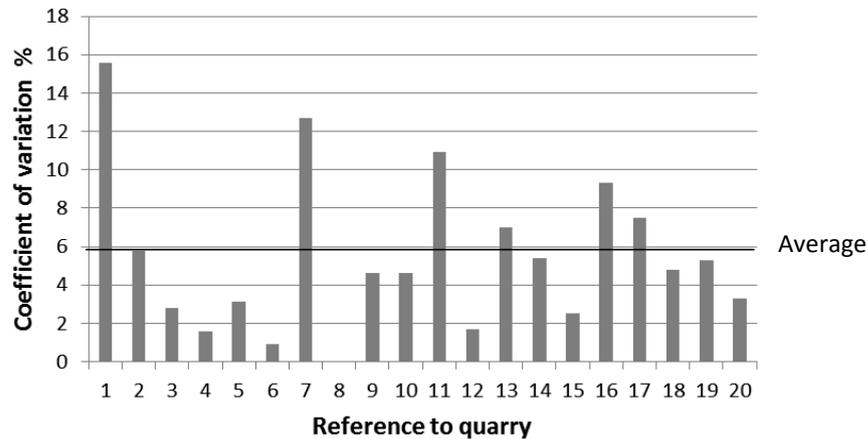
Figure 2.6 Coefficient of variation (COV) for Los Angeles abrasion values (modified after Cuelho et al. 2007).

Cuelho’s (2007) single-lab repeatability study also indicated that the COV value varied a lot from source to source (e.g. no.1, 7 and 11). This indicates that some materials in a scientific context should have been tested twice to achieve sufficient accuracy, but it is difficult to reveal which material that needs this handling due to lack of knowledge about what rock properties that cause this variation in test results. This PhD project has used only one test (replica) to determine the Los Angeles value to an aggregate material.

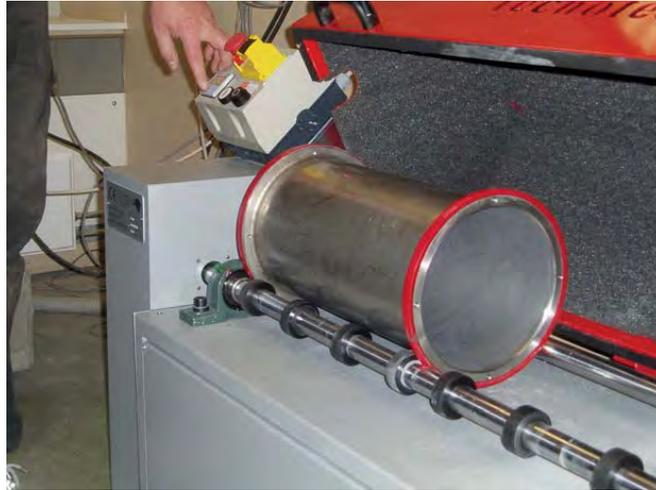
Figure 2.7 The micro-Deval test cylinder for fraction 31.5/50 mm ballast.

The micro-Deval test is run wet (standard procedure) and measures the aggregates’ resistance to wear which means that the particles are forced to rub against another in a rotating steel cylinder. The test was adopted by the Norwegian National Railway Administration in 2008 to assess mechanical strength of railway ballast materials together with the Los Angeles test. In this study the micro-Deval test has been performed according to both EN-NS 1097-1 on 10/14 mm (road materials) and EN-NS 13450 on 31.5/50 mm (railway materials), see Table 2.3. The coarse fraction uses a cylinder with length 400 mm (Figure 2.7), and the finer fraction uses a cylinder with length 154 mm. The inside diameter is 20 cm for both.

Test sample is not soaked in water prior to the test even though this is a wet test. After the test the aggregate is sieved on a 1.6 mm sieve. The amount of dry material passing the sieve expresses the micro-Deval value in percent of the sample's total weight (calculated as average of two analyses).

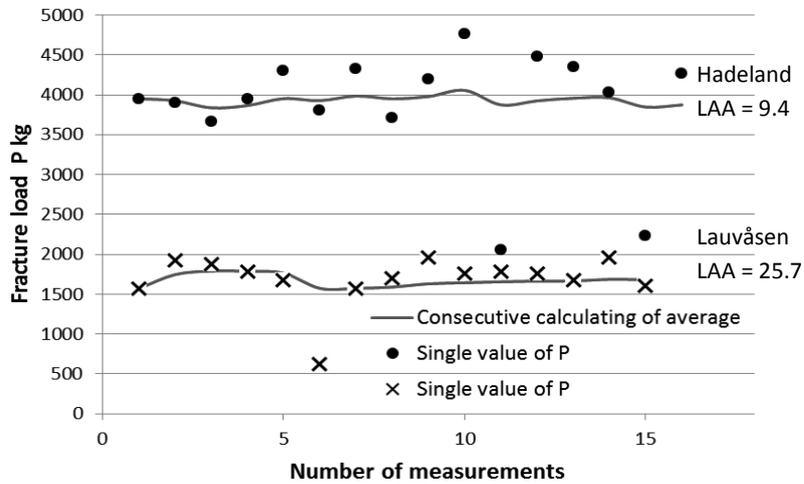
Figure 2.9 Example of calculation of arithmetic value of fracture load P for two rocks as a function of number of measurements. Core diameter D was 50 mm. LAA values relate to fraction 31.5-50 mm.

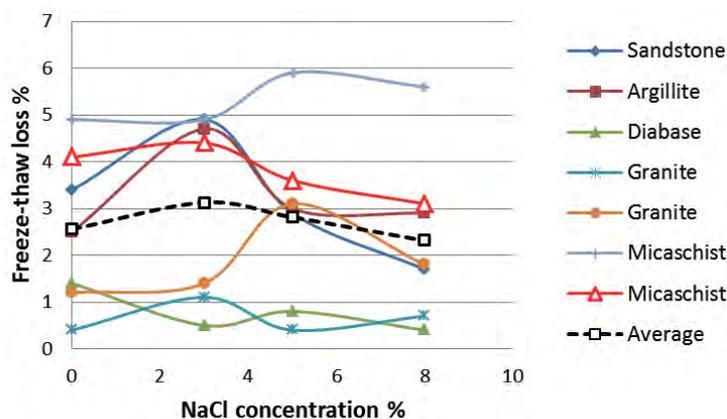
Figure 2.10 Correlation between sodium chloride concentration and freeze-thaw degradation (weight loss), modified after Verbech and Klieger 1957.

The freeze-thaw test with NaCl solution was conducted according to standard specification which says 1 % NaCl. However, an investigation by Verbech and Klieger (1957) on frost resistance for 25 rocks with test fraction 4.5/19.5 mm, ten freezing cycles (ten times 24 hours) and four different NaCl concentrations (0, 3, 5 and 8 %) found that the strongest impact from NaCl occurred with concentrations between about 2 and 6 % as shown in Figure 2.10.

Only seven out of 25 rock samples, assumed to be most relevant compared with Scandinavian conditions, are displayed in the diagram together with average values (dotted line). The remaining 18 rocks which had very poor resistance to freezing were skipped. It can be seen that the NaCl concentration with maximum impact varies from rock to rock with a maximum average value around 3 % sodium chloride. Some rocks respond on low concentrations of sodium chloride, others at higher concentrations.

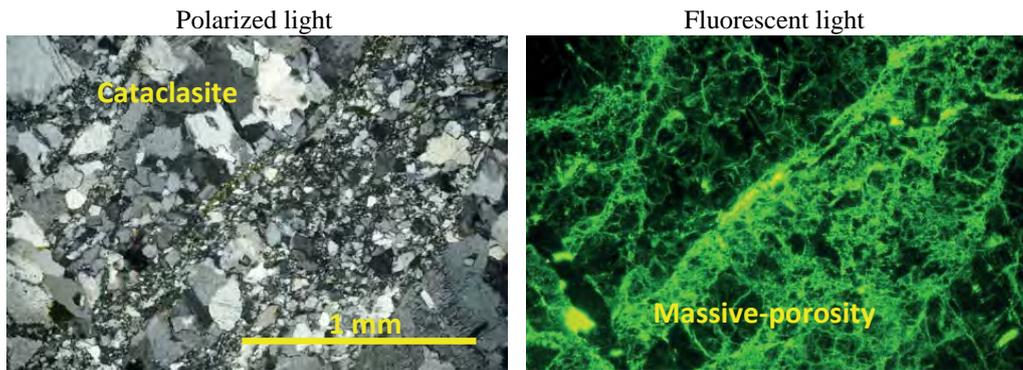
Figure 2.11 Micro images of thin section (Aplitt cataclasite) with massive porosity.

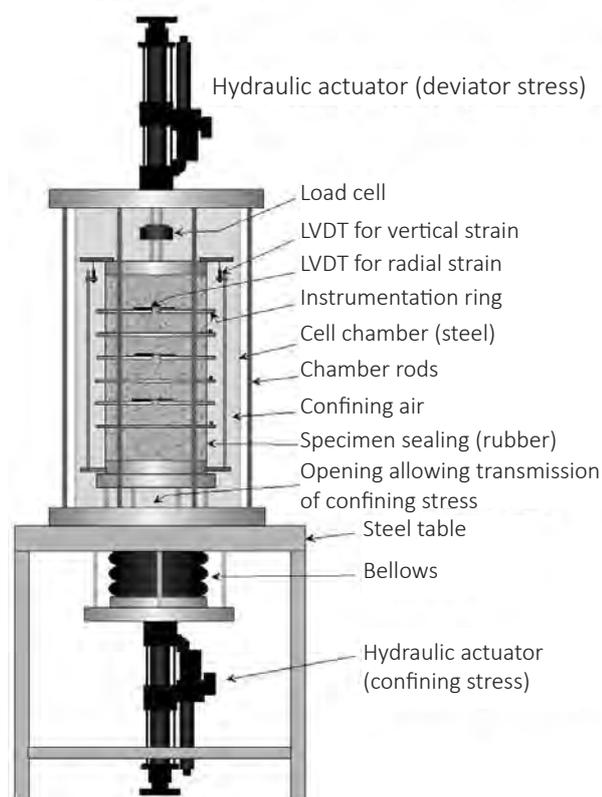
Figure 2.13 The triaxial cell apparatus with specimen, cables not shown (Skoglund 2002).

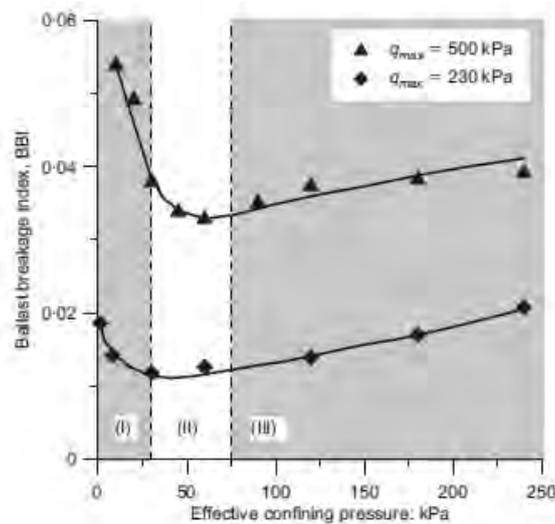
Figure 2.14 Effect of confining pressure on particle degradation at different deviatoric stress levels (Indraratna et al. 2005).

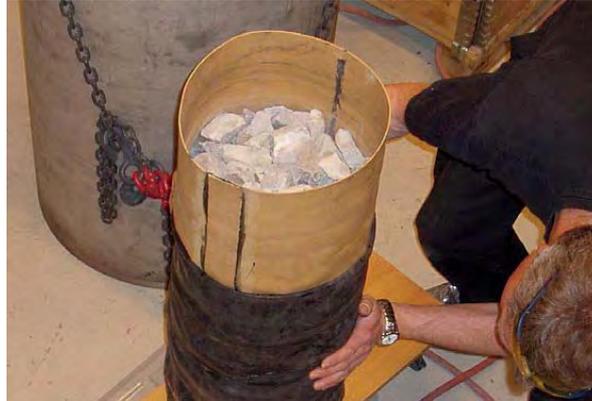
Figure 2.17 Preparation of a test specimen.

The number of aggregate particles at the top and the bottom of the sample (Figure 2.17) in contact with the loading plate will change randomly from step 1 through step 4.

The transformation of the stress from the top to the bottom of one sample will be different from step to step. Consequently, the contact stress between the aggregate particles and the ability to particle edge wear or breakage will also change and thus the recorded amount of ballast breakage will vary.

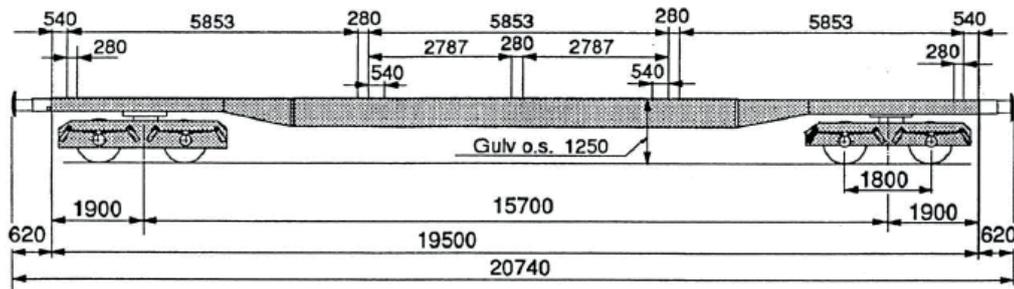
Figure 2.18 Container carriage with four axles (bogie), measures in millimetre (Norwegian Railway Company 2000).

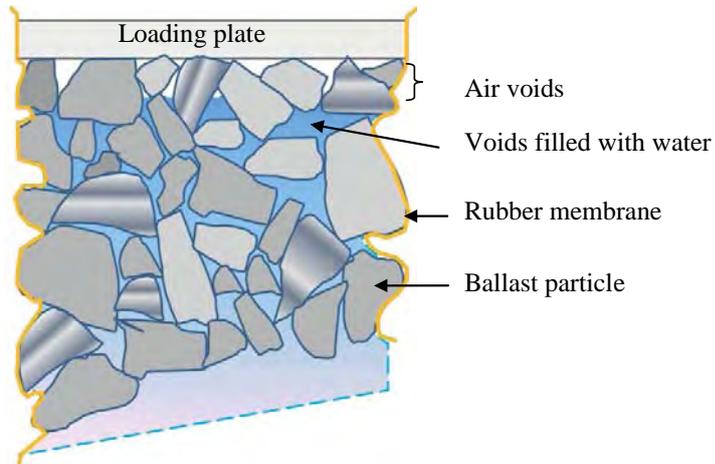
Figure 2.20 Upper section of a wet triaxial test specimen ready for loading, almost completely filled with water.

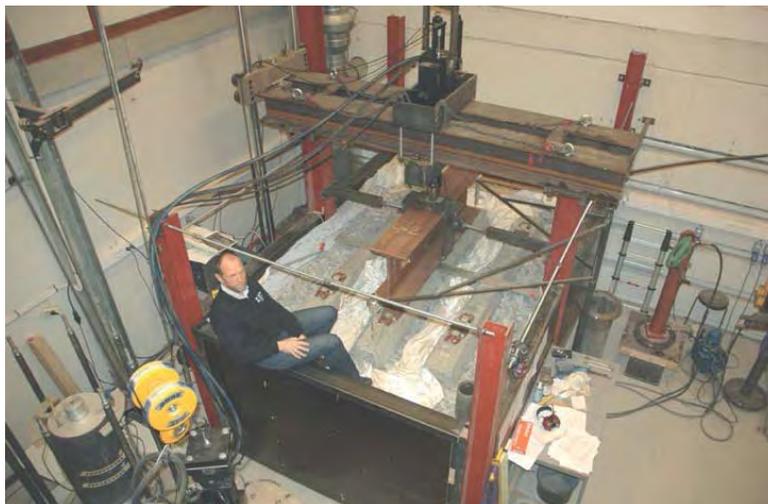
Figure 2.22 Full scale rail track model test equipment for cyclic loading simulating train traffic and tamping.

The general test setup is shown on Figure 2.21. A 300 mm thick layer of crushed rock ballast was confined within a rigid test box 3 m long by 1.5 m wide with plywood bulkheads supported with wood bars, and steel bars in the corners (Figure 2.22).

Repeated load between 5 kN to 125 kN was performed by a computer-controlled closed-loop electrohydraulic actuator working on a I-beam that distributed 62.5 kN to each of the rail seats for a duration equivalent to about 100 million gross tons (MGTs) of axle loading in track. The equivalent axle tonnage was calculated by summing the number of load repetitions and multiplied by twice the applied load (25 tons axle load * $4 \cdot 10^6$ loadings = 100 million tons).

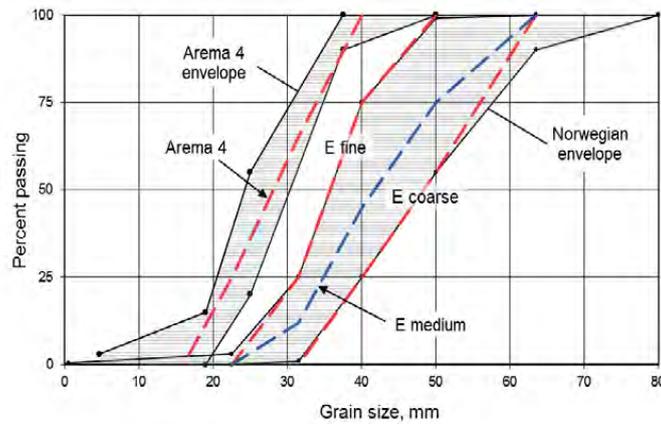
Figure 3.1. Ballast grading curves employed in the large scale triaxial tests and the full scale rail track model test.

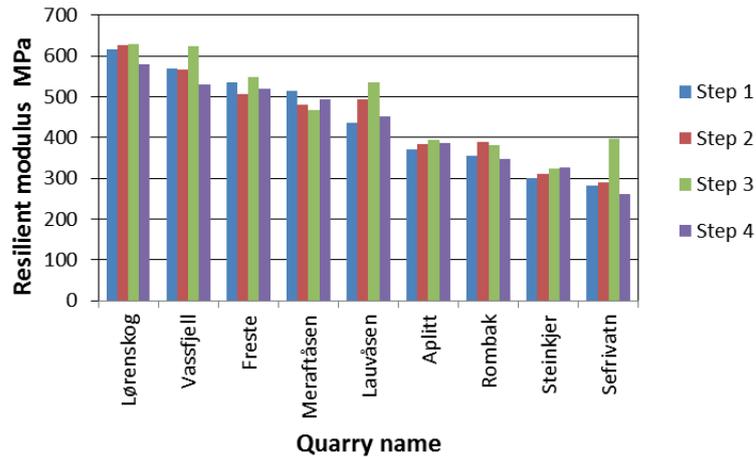
Figure 4.1 Elastic properties (dry state) to nine different rock types. Number of loadings are 1 million for each step.

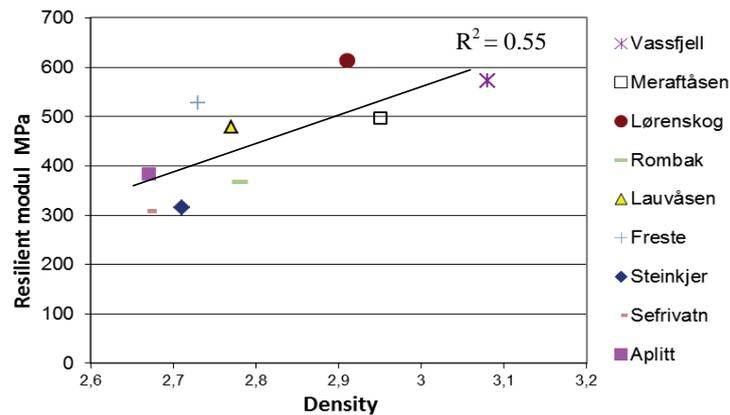
Figure 4.2 Relationship between ballast elastic property and rock density

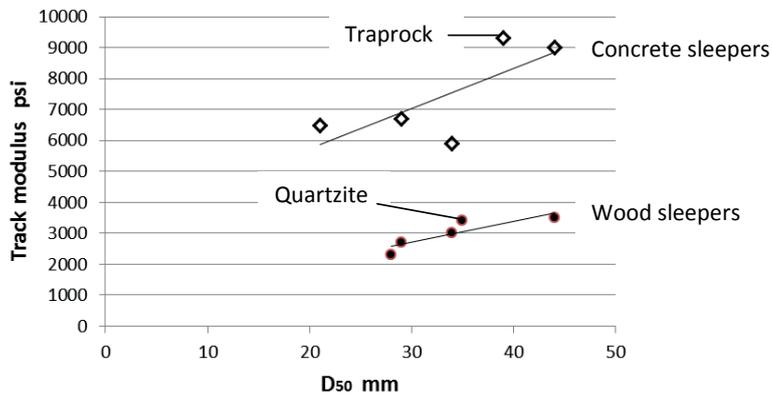
Figure 4.5 Variation in track modulus with ballast particle size. Regression coefficient R^2 for concrete sleepers is 0.55 and for wood sleepers 0.77. Test materials are different types of granite with two exceptions. 1 psi = 6.89 kPa. Modified after Bosserman 1981.

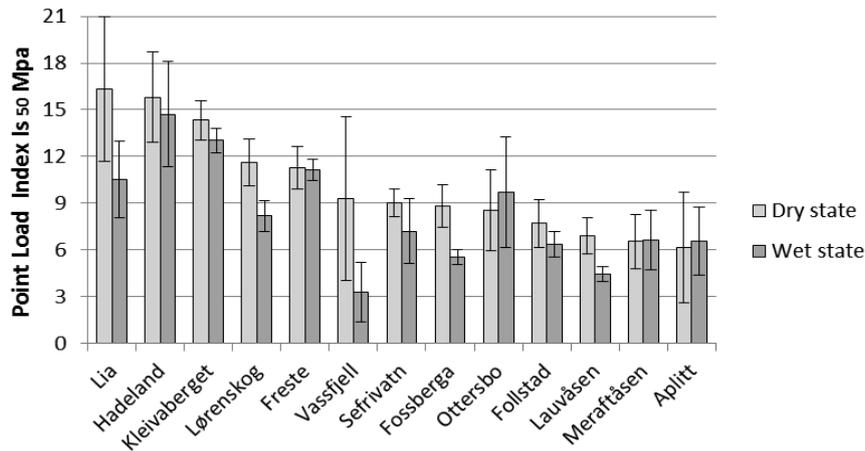
Figure 4.8 Histogram of Point Load test results from both dry and wet state with one standard deviation added.

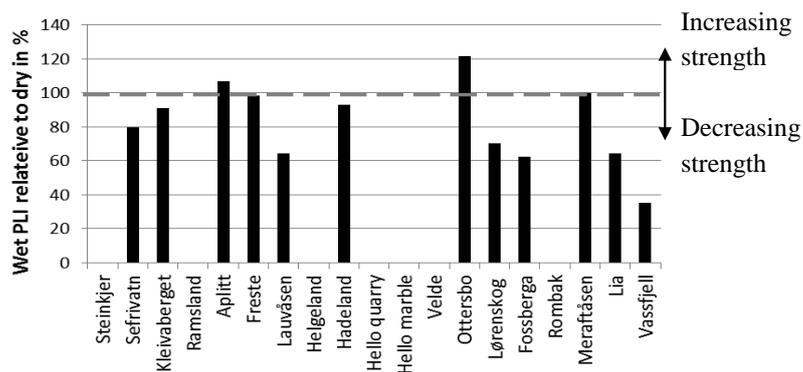
Figure 4.9 Point Load Index (Is₅₀) or tensile strength for water saturated rocks in per cent of the strength of air dried rocks. Drilled core diameter was 50 mm.

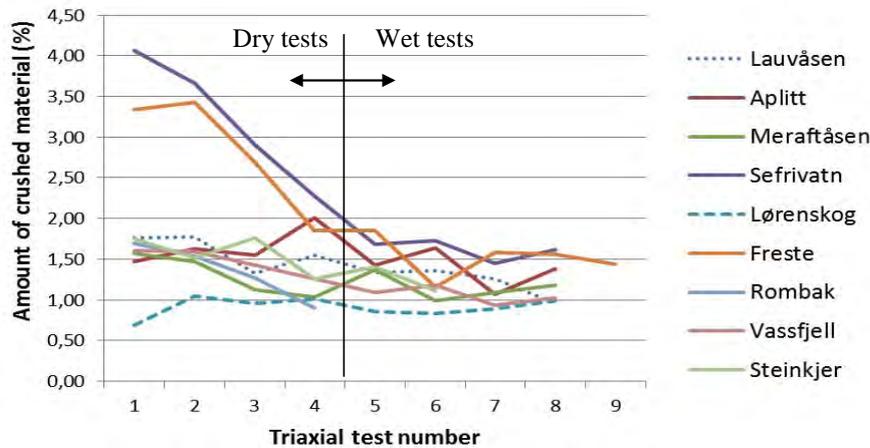
Figure 4.12 Amount of crushed material 0/22.4 mm after each triaxial test. The test fraction at the beginning of each test was 22.4/63.0 mm. Number 1 to 4 represent dry state, and 5 to 8 represent wet state. Mica gneiss from Rombak was tested only in dry state.

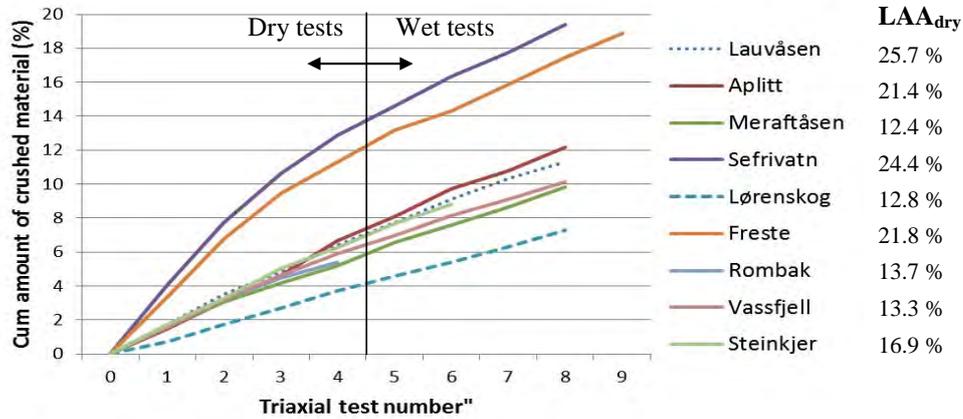
Figure 4.13 Cumulative amounts of crushed material 0/22.4 mm after 8 triaxial tests. Freste was tested 9 times. Test number 1 to 4 represents dry state, and number 5 to 8 represents wet state. Mica gneiss from Rombak was tested only under dry conditions. All rocks are fine to very fine grained except Freste.

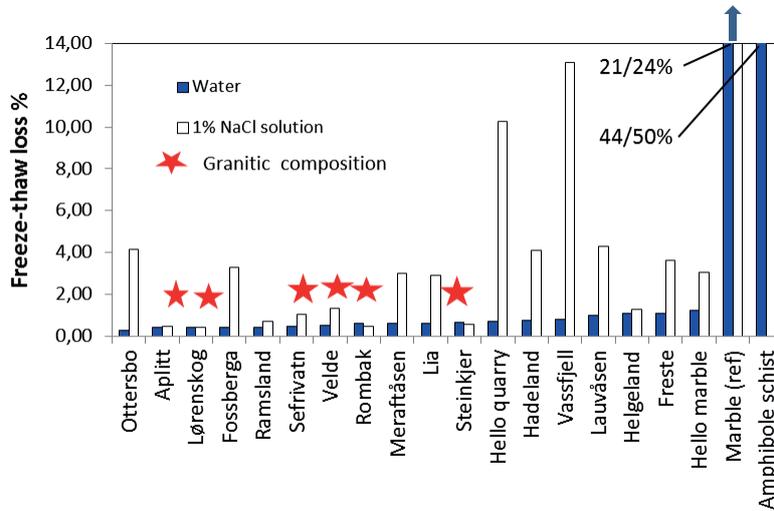
Figure 4.14 Freeze-thaw results for 20 different rock types (fraction 8/16 mm) after 150 freeze-thaw cycles. Carbonate rock and amphibole schist are samples with documented low frost resistance from field experience and used here for comparison.

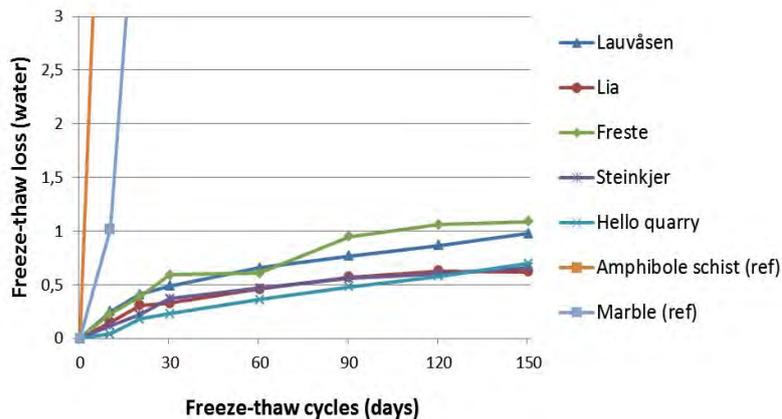
Figure 4.15 Example of long term recording of frost resistance of Norwegian rocks (water). Freeze-thaw loss in % of dry weight. Fraction 8/16 mm and 1 kg sample weight.

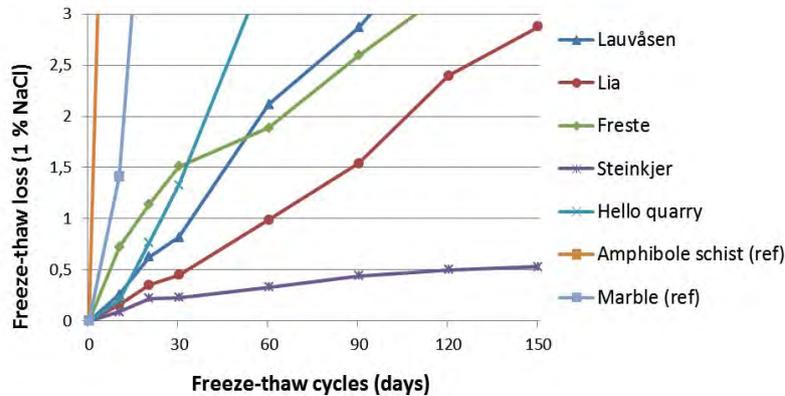
Figure 4.16 Example of long term recording of frost resistance in 1 % NaCl solution. Freeze-thaw loss in % of dry weight. Fraction 8/16 mm and 1 kg sample weight.

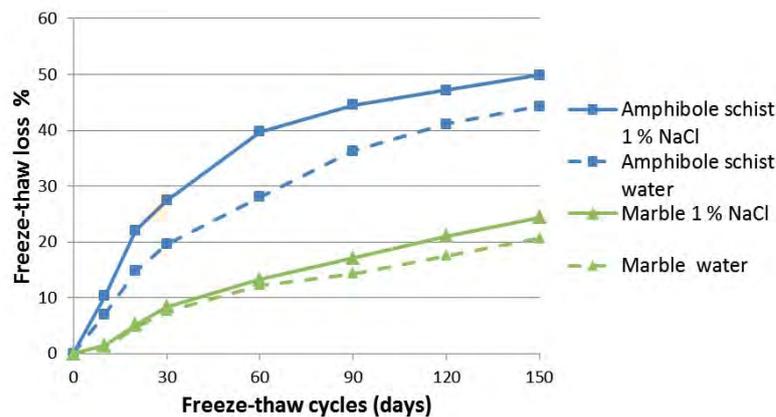
Figure 4.17 Long term weathering curves for two rocks with confirmed low frost resistance (the reference rocks from Beiarn, Nordland county).

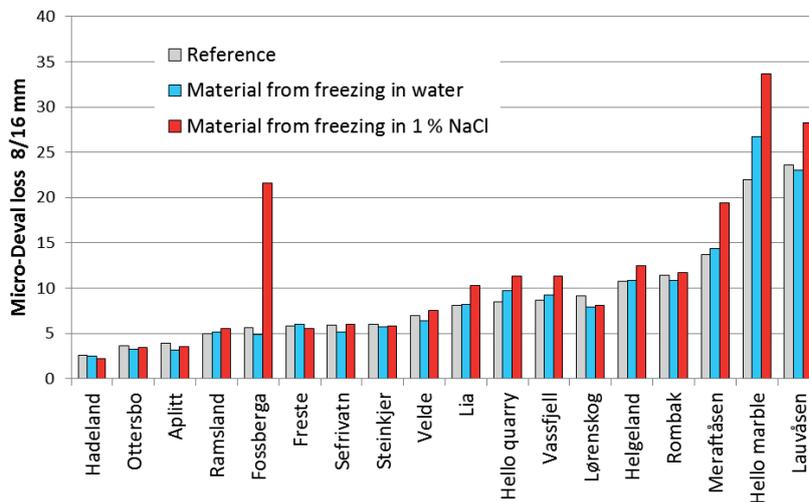
Figure 4.18 Micro-Deval test run on aggregates (8/16 mm) after subjected to 150 freeze-thaw cycles.

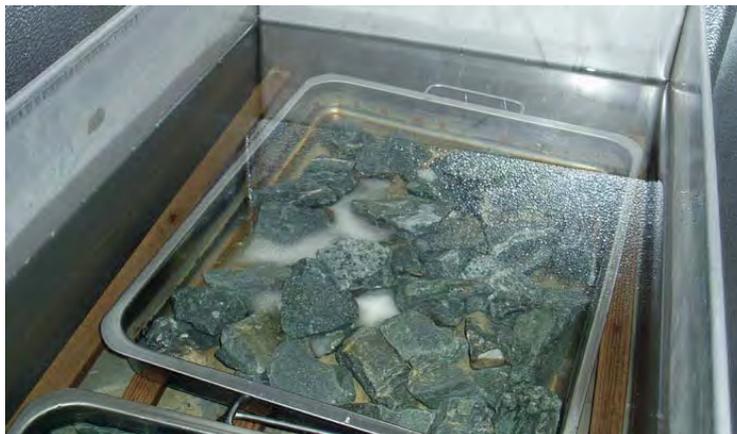
Figure 4.20 Thawing phase of the test. Test material was soaked in water during both freezing and thawing.

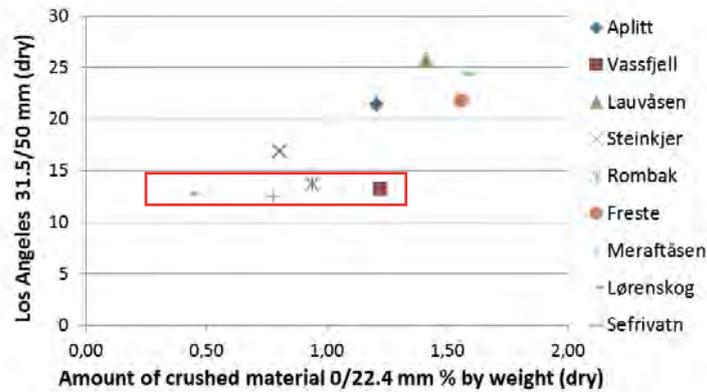
Figure 4.26 Total amount of crushed material from full scale model test (4x1 million loadings and dry state) related to mechanical strength (LAA dry). $R^2=0.64$.

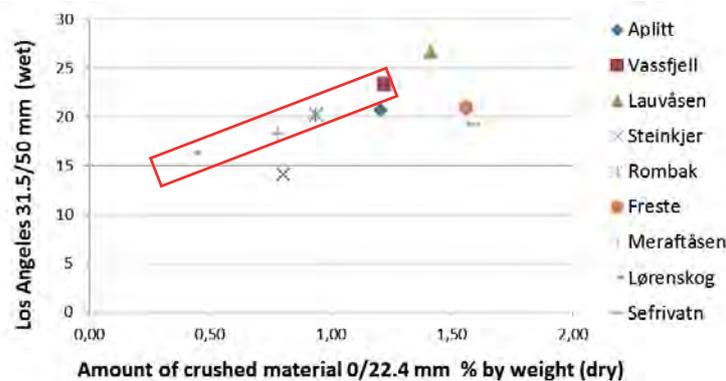
Figure 4.27 Total amount of crushed material from full scale model test (4x1 million loadings (dry state) related to mechanical strength ($LAA_{31.5/50 \text{ m wet}}$). $R^2=0.41$.

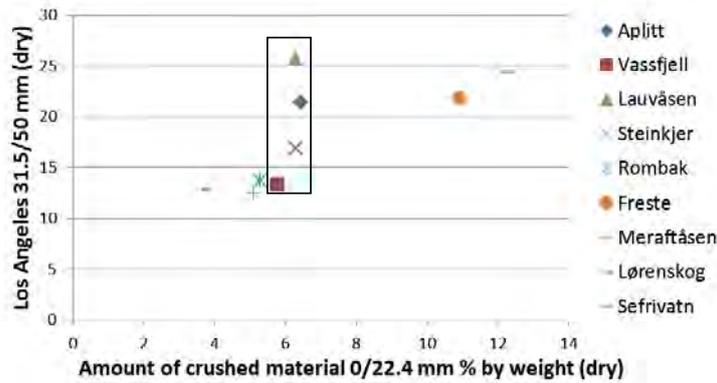
Figure 4.28 Total amount of crushed material from triaxial testing (4x1 million loadings (dry state) related to mechanical strength ($LAA_{31.5/50 \text{ mm dry}}$). $R^2=0.77$.

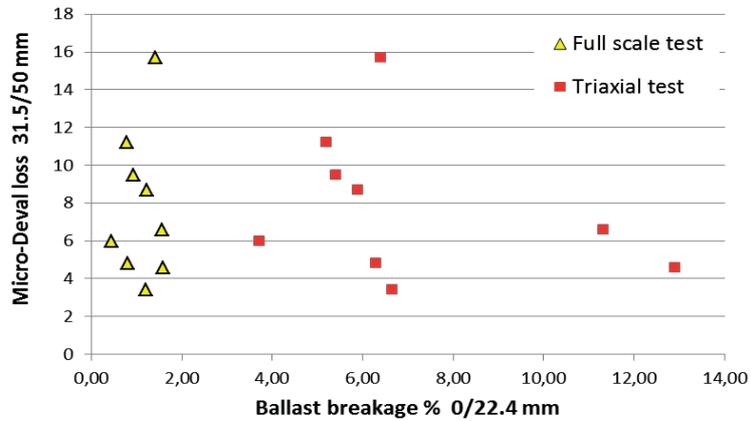
Figure 4.31 Correlation between micro-Deval and ballast breakage after both triaxial testing (dry/red) and after full scale model test (dry/yellow).

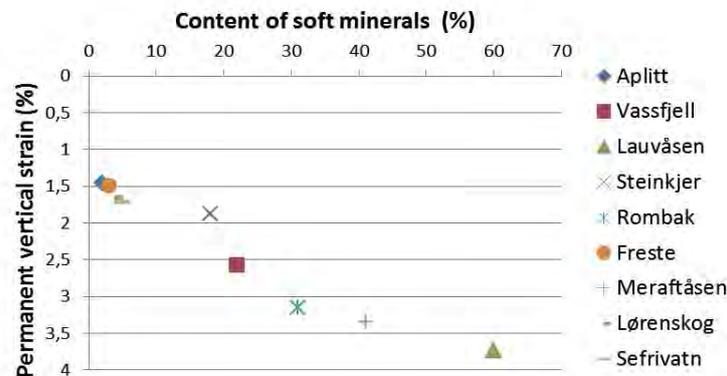
Figure 4.33 Permanent vertical strain from triaxial tests (dry) compared with rocks' content of soft minerals (mica, chlorite and carbonate). Regression coefficient (R^2) is 0.95.

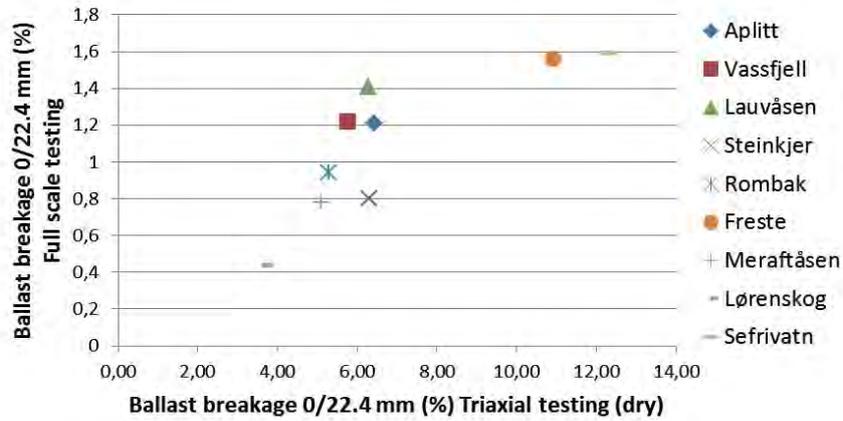
Figure 4.34 Comparison between cyclic triaxial testing and full scale rail track model testing in terms of ballast breakage (0/22.4 mm). Original grading 22.4/63 mm.

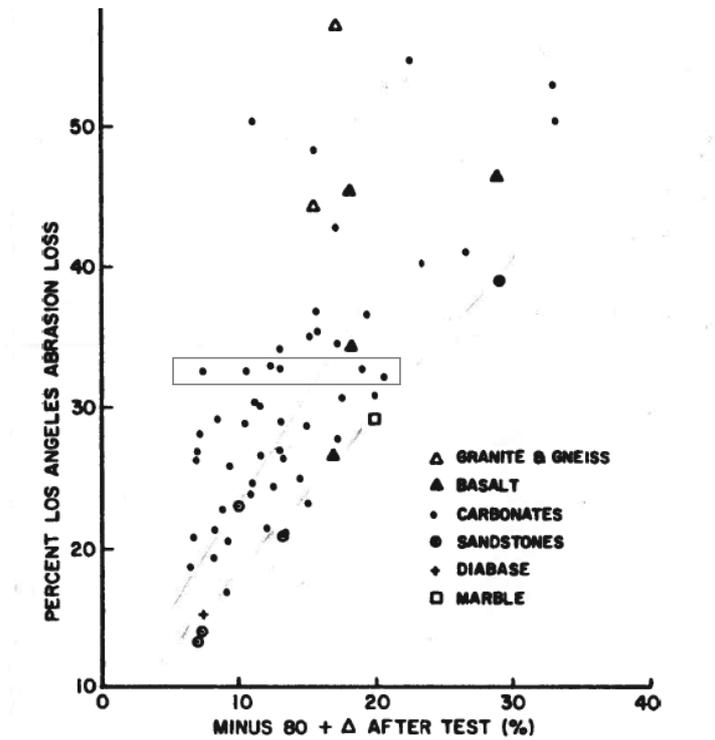
Figure 4.36 Production of fines versus Los Angeles abrasion loss for several rock types. Sieved on sieve no. 80 (0.178 mm). Modified after West et al. 1970.

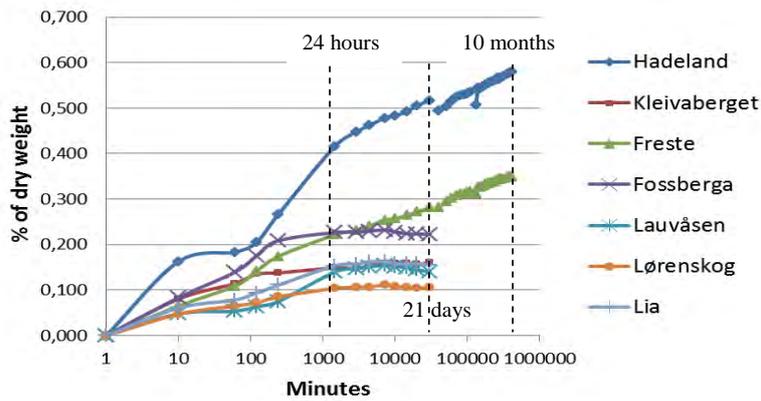
Figure 4.41 Absorption of water on drilled cores. No vacuum used.

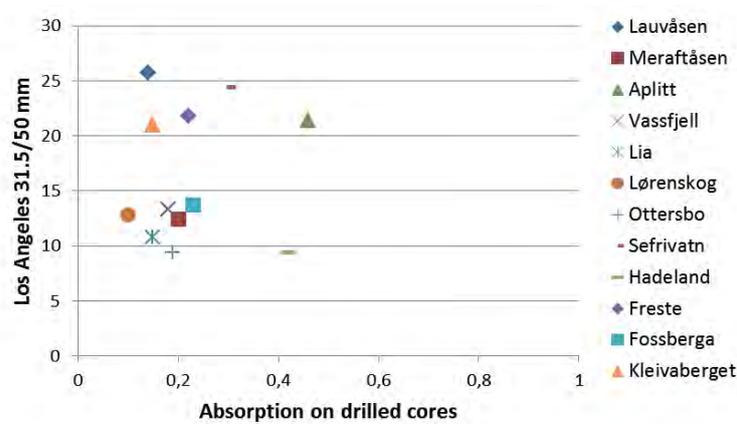
Figure 4.42 Correlation between dry Los Angeles abrasion loss $_{31.5/50 \text{ m}}$ test and water absorption (24h) for drilled cores.

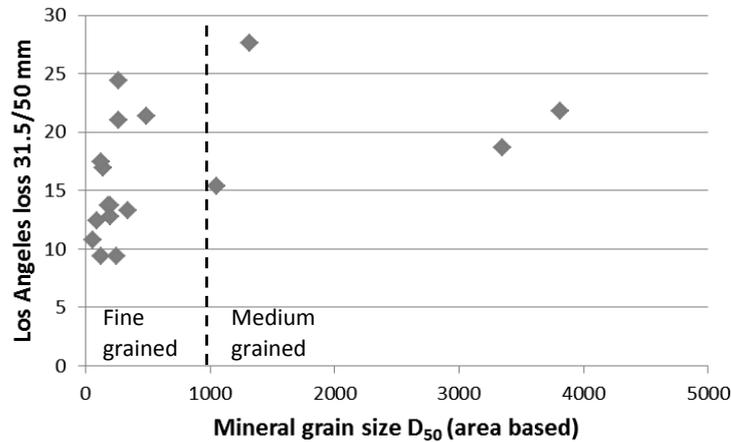
Figure 4.46 The significance of variation in average mineral grain size D_{50} on Los Angeles abrasion loss (mechanical strength).

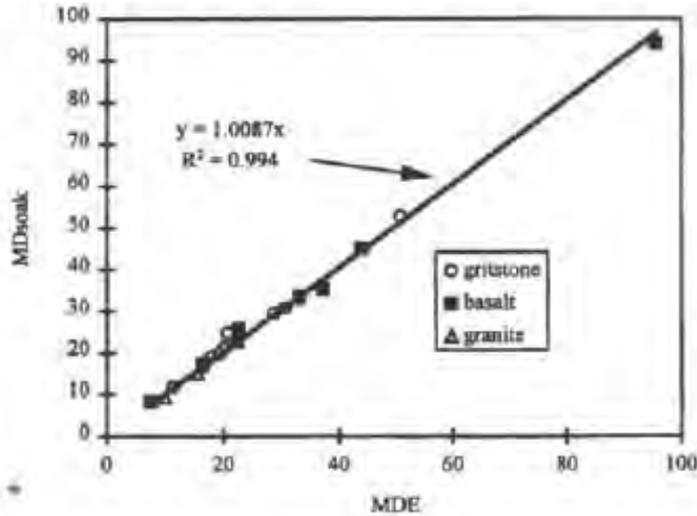
Figure 4.47 Correlation between wet and soaked micro-Deval loss (Woodside and Woodward 1998).

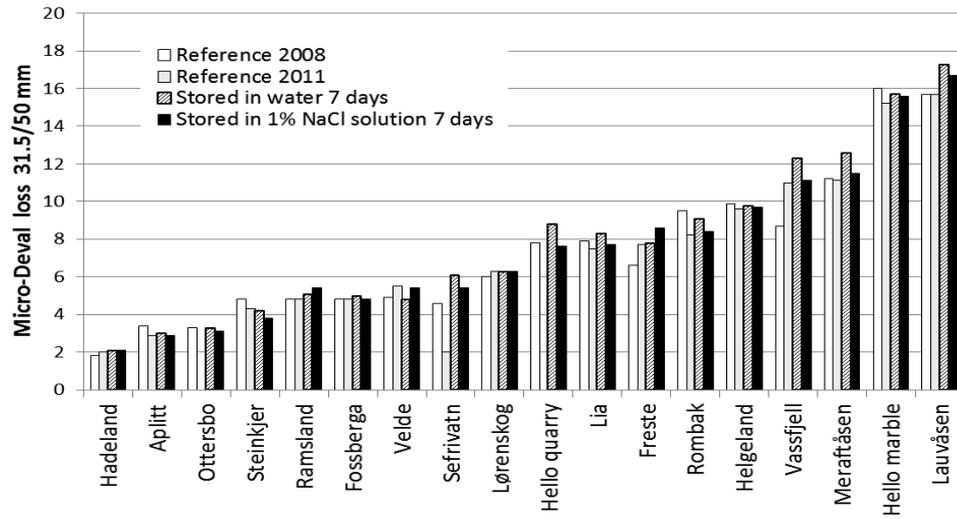
Figure 4.48 The effect from pre-treatment of test samples on micro-Deval values (fraction 31.5/50 mm).

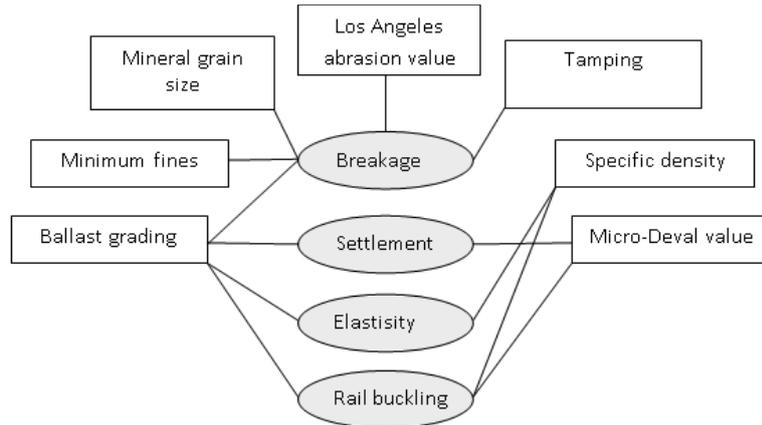
Figure 6.1. Impact from different variables on ballast breakage, track settlement, track stiffness and rail buckling

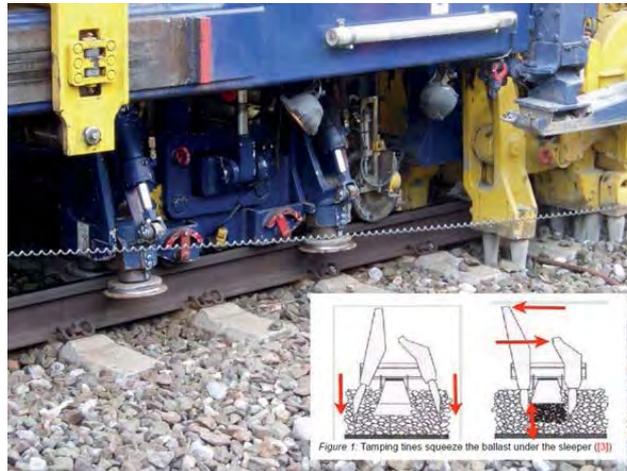
Figure 6.2 Maintenance of track alignment by tamping: 1) lifting track, 2) penetrating tines and 3) squeezing ballast (Selig and Waters 1994).

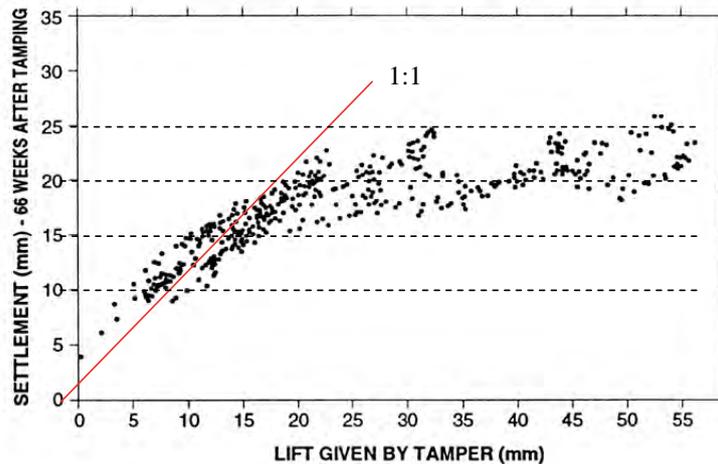
Figure 6.3 Measurement of sleeper settlements 66 weeks after tamping as a function of tamping lift (modified after Selig and Waters 1994).

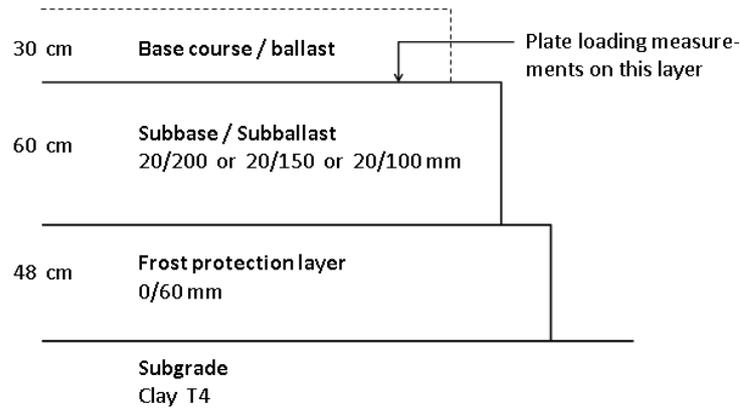
Figure 6.5 Vertical cross section of the design of Highway E6 between Trondheim and Stjørdal.

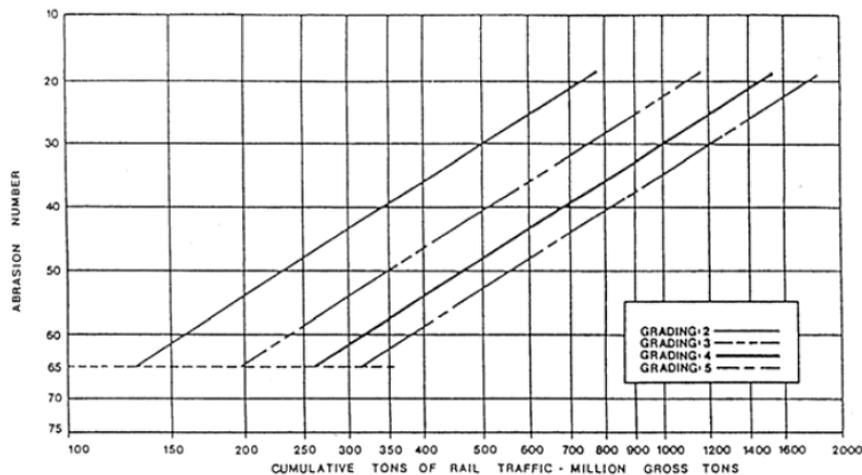
Figure 6.8 Cumulative tons of rail traffic versus ballast's mechanical strength (Clifton et al. 1987).

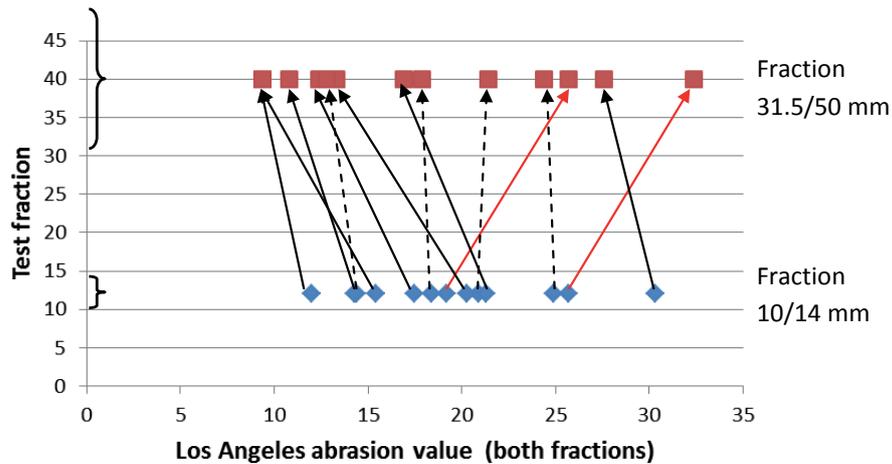
Figure 7.1 Los Angeles abrasion loss for a selection of rocks tested on fraction 10/14 mm and fraction 31.5/50 mm. Black lines marks decreasing values, dotted lines mark indifferent values and red lines mark increasing values when going from fraction 10/14 mm to fraction 31.5/50 mm

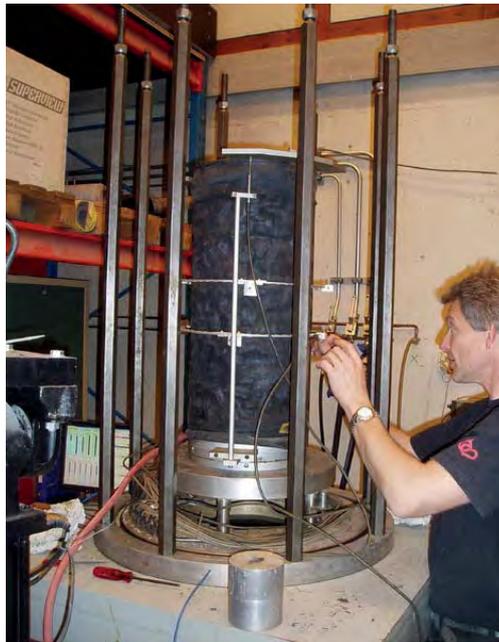
Figure 2 Instrumentation of a sample in the triaxial test rig

The equipment used in the present study is a large scale triaxial cell for repeated loading. The cell is earlier described by Skoglund et al. (4) and the triaxial unit has the capability of cycling both the deviatoric and the confining stress. It is primarily designed for testing of railway ballast, thus requiring large specimens typically 300 mm in diameter and 600 mm in height (Figure 2). The test unit comprises three main parts, a triaxial cell with two hydraulic loading actuators, a load control unit, and a data logger.

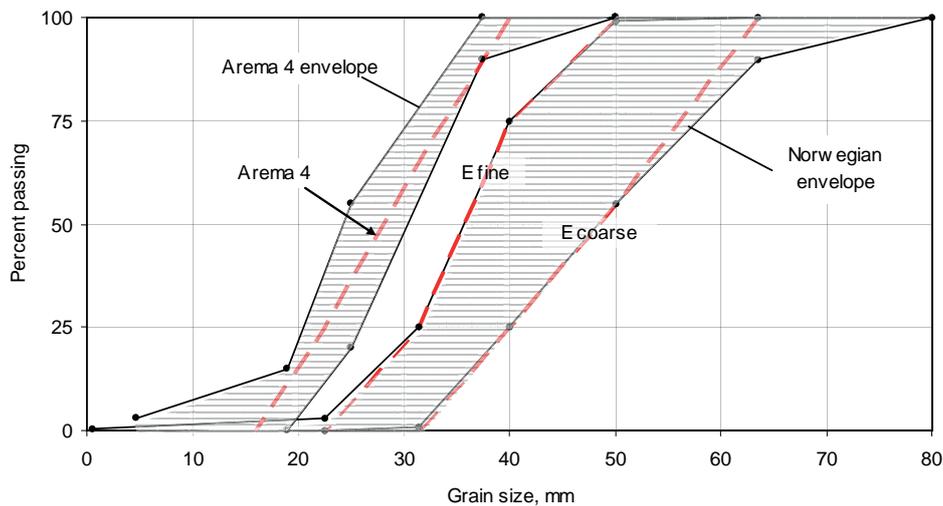
Figure 3 Grain size distribution curves for the three single-graded railway ballast samples used in this project (broken line).

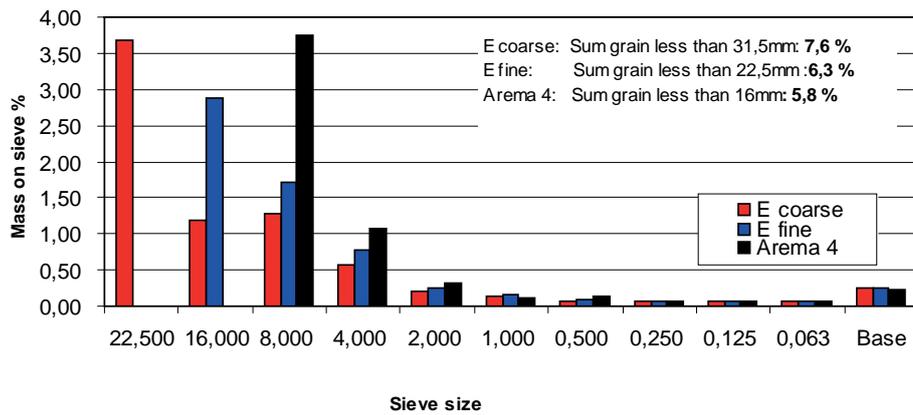
Figure 9 Amount of breakage material after the triaxial test (sum of four steps) less than Dmin in the original samples. Grading E coarse less than 31.5 mm, grading E fine less than 22.4 mm and Arema 4 less than 16.0 mm.
