Railway Ballast
Characteristics, Selection
Criterion and Performance

NTNU
Norwegian University of
Science and Technology
Thesis for the degree of
Philosophiae Doctor
Faculty of Engineering Science and Technology
Department of Civil and Transport Engineering

Trondheim, September 2014

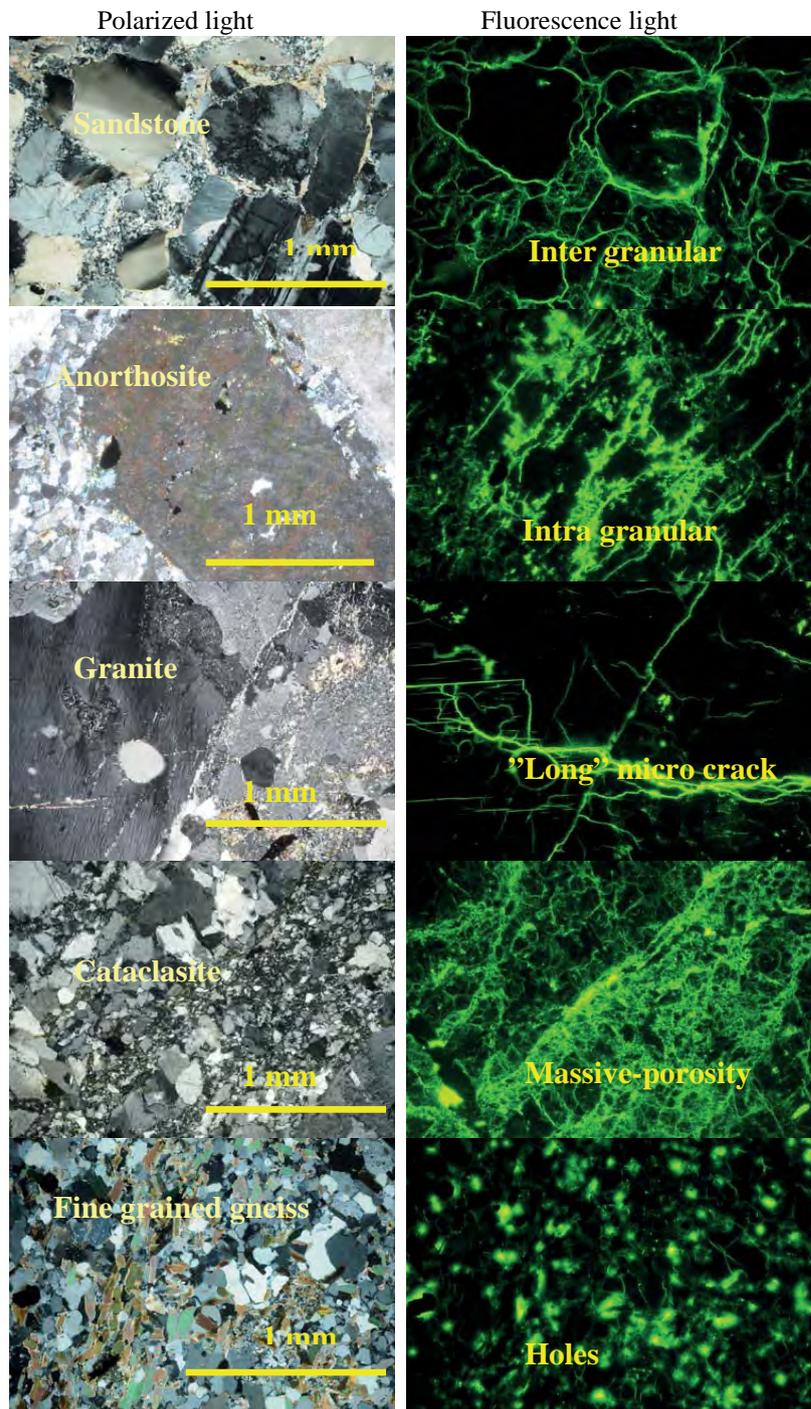
Figure 1: Micro graph of thin sections with 5 types of "micro cracks".

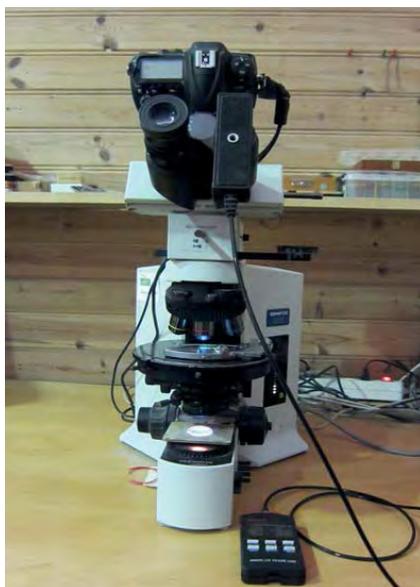
Figure 2: Microscope with Mavolux luminance sensor mounted in one eyepiece.

Different types of micro cracks occur in different amounts in thin sections and are therefore difficult to quantify. Moreover, quantification of micro cracks is not a standard procedure and the few published papers dealing with this subject have not given a “standardized” way to do it. Image analysis is one method being used for quantification of micro cracks in fluorescent impregnated thin sections but the results up till now are not promising. Image analysis may have problems quantifying distinct micro cracks in combination with more massive-porosity cracking and “holes” as observed in most of the aggregate samples in this study. Therefore a new measurement method was developed and used in the present doctoral project, namely luminescence measurement. The term “luminescence” has been used because light intensity has been measured in fluorescence light by use of UV filters in the microscope. Luminescence has been detected by use of a Mavolux Digital Luxmeter 5032B with the luminance attachment sensor mounted in one of the eyepieces of the microscope, see Figure 2. The Mavolux 5032B is suitable for measurement of extremely low light intensities with initial sensitivity of 0.01 lx (Lux).

The following procedure has been used for all the measurements. First all unnecessary filters were removed from the microscope to obtain maximum light intensity. Fluorescence light was obtained by using a primary filter (SWP 490) and a secondary filter (LP 520). By use of an object stage, the same coordinate system with 5 x 5 measurements point covering an area on 10 mm x 15 mm of the thin section was used by all the measurements. The used objective was 10 x magnified covering an area on 3.5 mm², hereby the total measurement area was 25 x 3.5 mm² = 87.5 mm². Measurements with defects or larger holes were excluded and therefore, the total numbers of measurements in some cases are less than 25. To detect possible drift or errors, measurements were checked by a standard with known Lux value before and after measurements. Measurement results from the Mavolux were transferred via an USB port to a data program in a PC and Excel spread sheets. The average luminescence in Lux was calculated and has been presented as average arithmetic values from all thin sections representing the aggregate deposit as shown in Table 2. In some of the aggregate deposit a rather large variation in luminescence has been detected between the thin sections explaining the rather large standard deviation shown in Table 2. This is probably caused by different aggregate types or variation in alteration in many of the aggregate deposits.

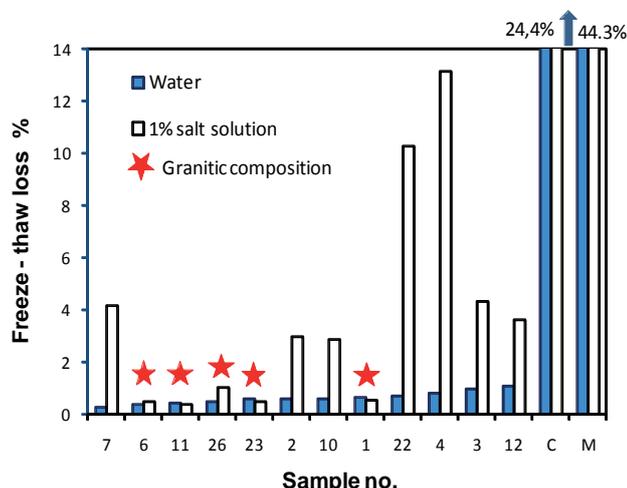
Figure 9: Freeze-thaw results for 14 different rock types (fraction 8-16 mm) after 150 freeze-thaw cycles. C = carbonate rock and M = mica amphibole schist.

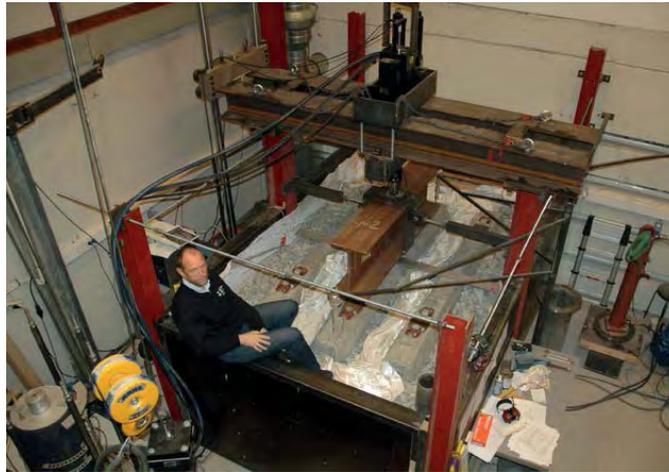
Figure 2: Full scale rail track model test setup for cyclic loading.

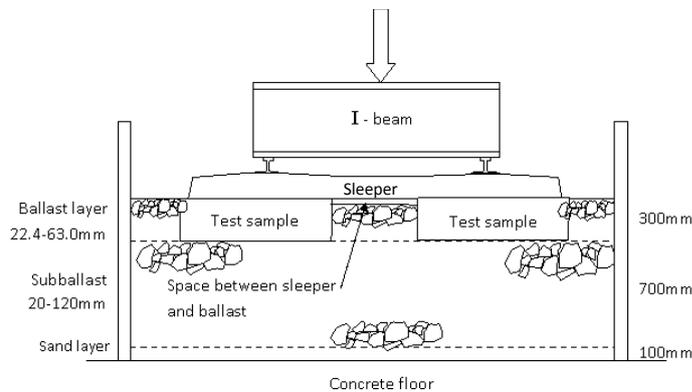
Figure 3: Cross-section of the full scale rail track model test setup.

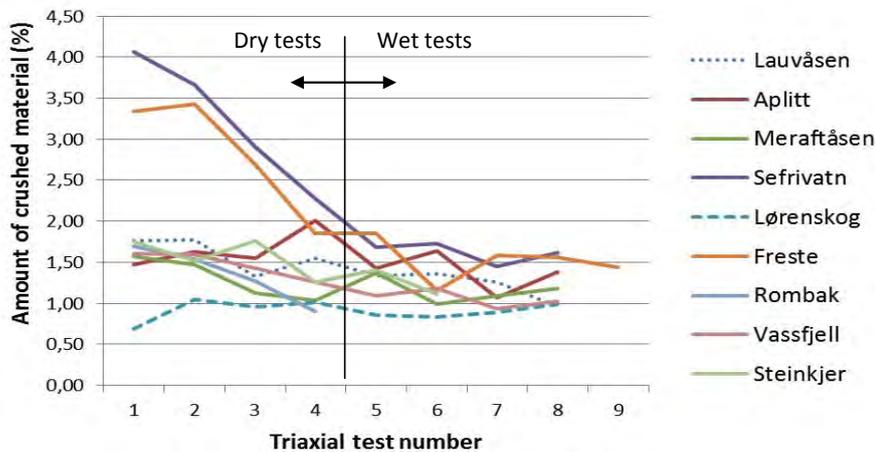
Figure 4: Amount of crushed material 0-22.4 mm after each triaxial test. The test fraction at the beginning of each test was 22.4- 63.0 mm. Number 1 to 4 represent dry state, and 5 to 8 represent wet state. Mica gneiss from Rombak was tested only in dry state.

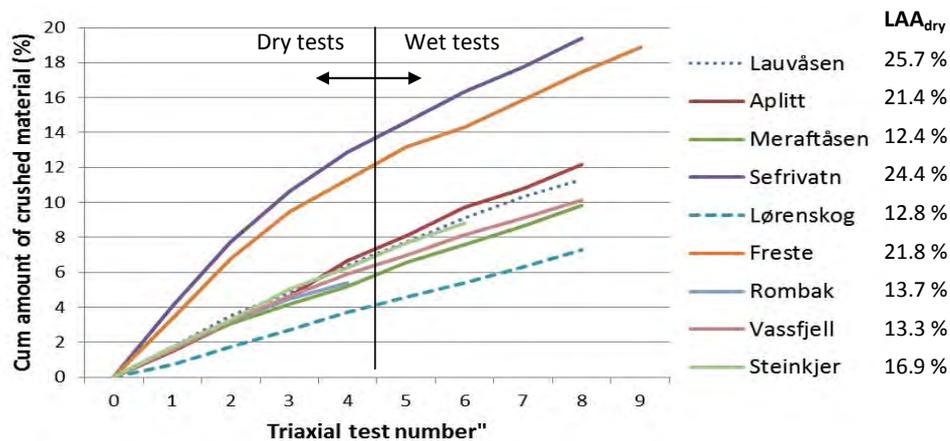
Figure 5: Cumulative amounts of crushed material 0-22.4 mm after 8 triaxial tests. Freste was tested 9 times. Test number 1 to 4 represents dry state, and number 5 to 8 represent wet state. Mica gneiss from Rombak was tested only under dry conditions. All rocks are fine to very fine grained except Freste.

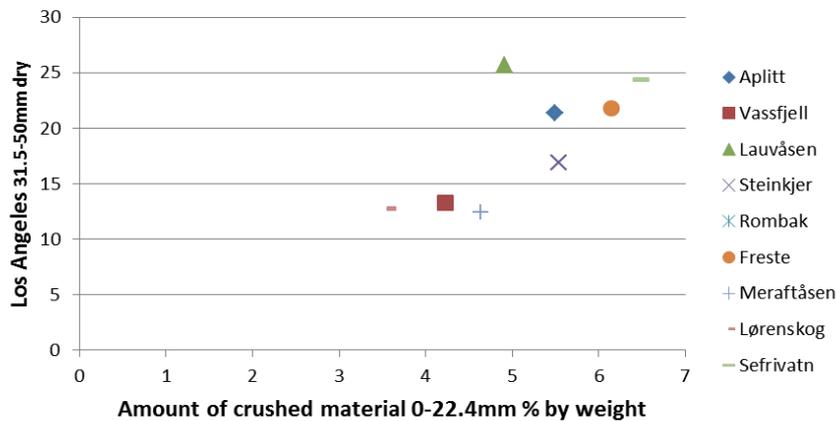
Figure 6: Correlation of LAA (dry) against cumulative wet triaxial test breakage (four repetitions and totally 4 million loadings). Ballast test fraction 22.4-63 mm. R^2 without Lauvåsen is 0.83.

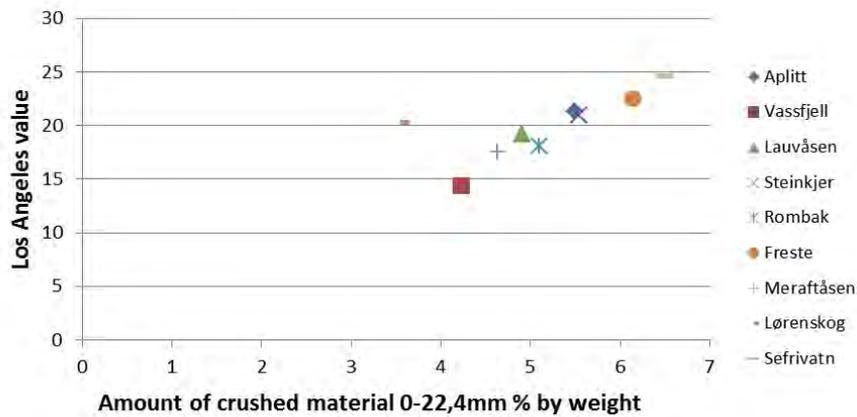
Figure 7: LAA values (10-14 mm) plotted against breakage from triaxial tests performed in wet state (4 million loadings). R^2 without Lørenskog is 0.97.

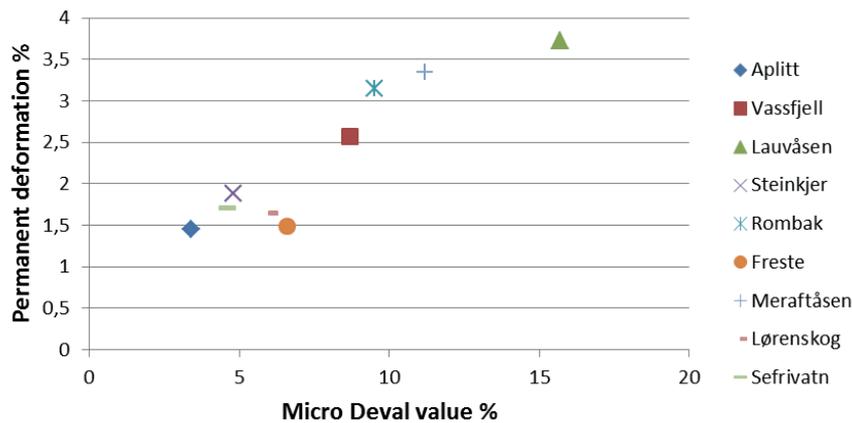
Figure 8: Ballast permanent deformation from dry triaxial tests (4x1mill loadings) plotted against micro-Deval values (31.5-50 mm). R^2 is 0.86 with Lauvåsen included.

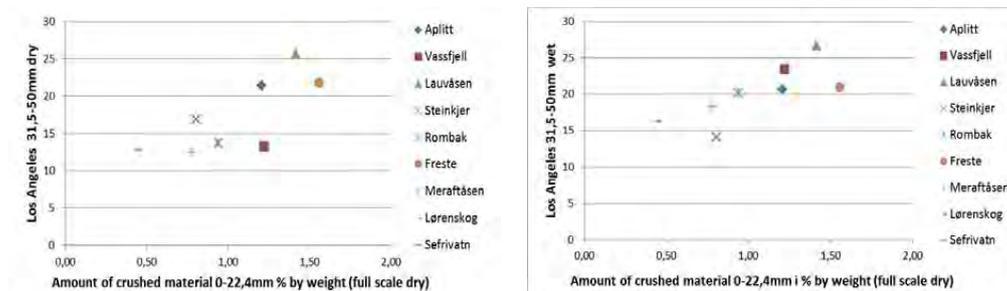
Figure 9: Total amount of crushed material from full scale model test (4x1 million loadings /only dry state) plotted against $LAA_{31.5-50mm}$. Left: dry state with $R^2 = 0.56$. Right: wet state with $R^2 = 0.58$, but increase to 0.73 when Freste (medium grained) is removed.

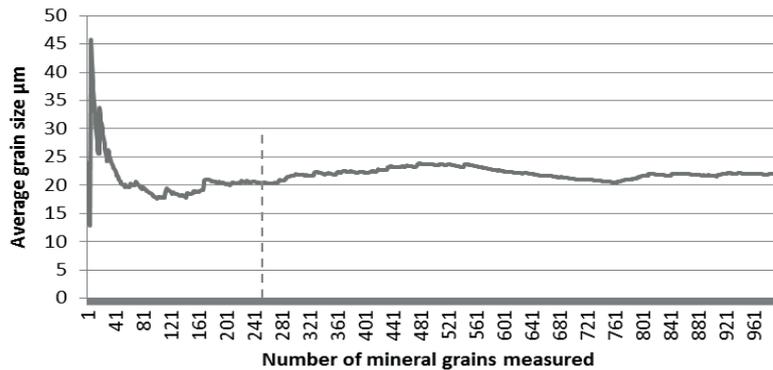
Figure 2: The plot shows the relation between calculated average mineral grain size (arithmetic) and the number of grains counted (Steinkjer quarry). Note that average grain size is stable after approximately 250 measurements.

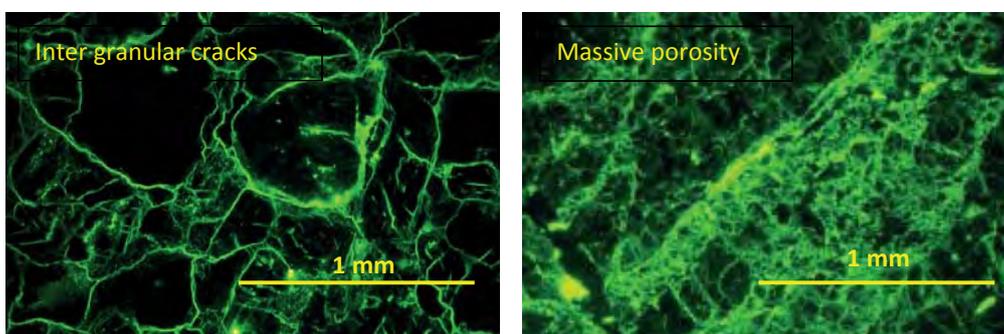
Figure 11: Examples of thin section (meta sandstone (left) and cataclasite (right)) in fluorescence light. Transmitted light was measured in Lux to express the average amount of both micro-cracks, porosity and holes.

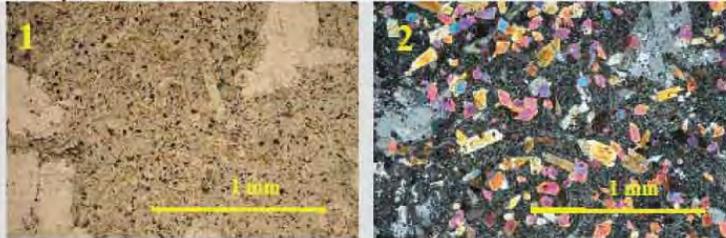
Micro photos of selected area in thin section

- 1 Ordinary light. Note plagioclase porphyres
- 2 Polarized light. Note euhedral epidote crystals
- 3 Fluorescence light. Note micro cracks

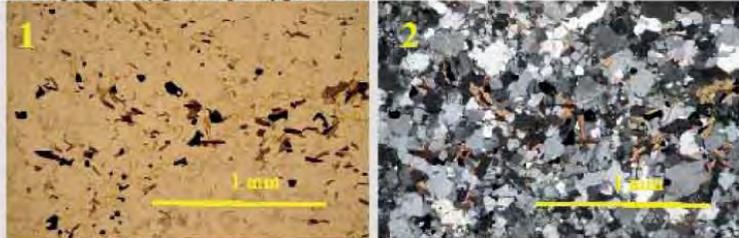
Micro photos of selected area in thin section

1 Ordinary light. Note biotite (light brown-red brown)

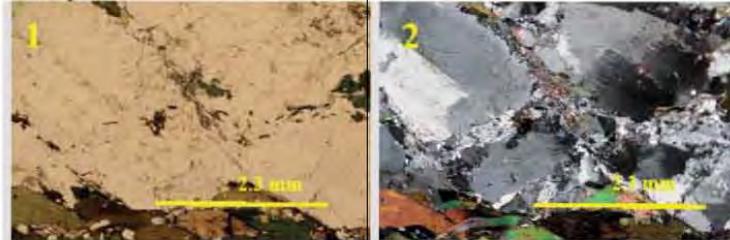
Micro photos of selected area in thin section

1 Ordinary light. Note intergrown hornblende and biotite (brown - green)

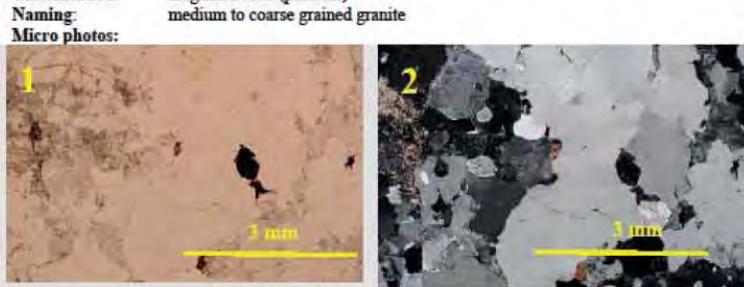
Micro photos of selected area in thin section

1 Ordinary light.

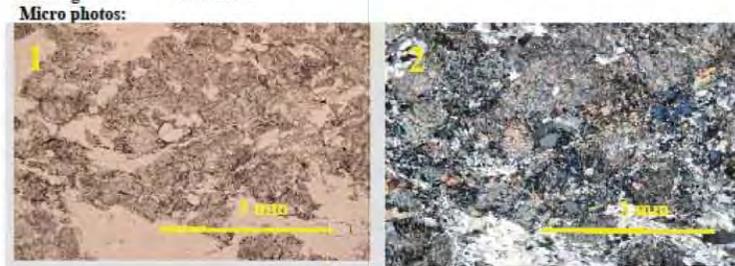
Micro photos of selected area in thin section

1 Ordinary light. Note lack of orientation (foliation)

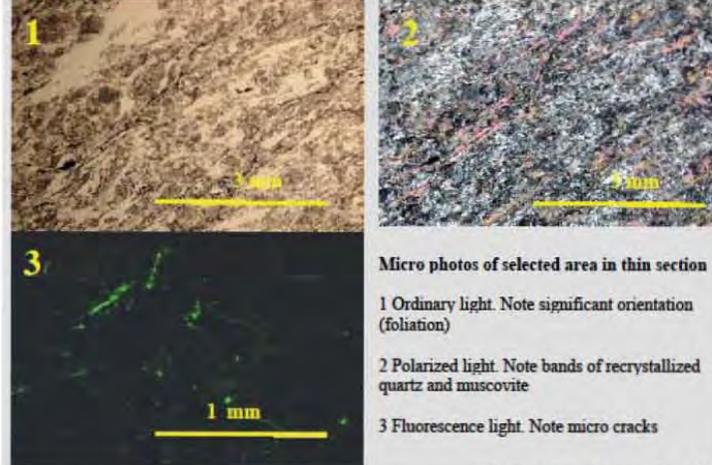
Micro photos of selected area in thin section

1 Ordinary light. Note significant orientation (foliation)

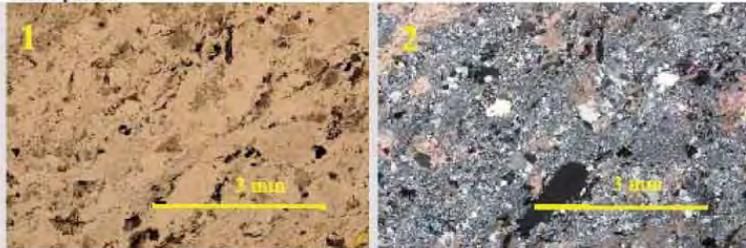
Micro photos of selected area in thin section

1 Ordinary light. Note biotite/chlorite (brown), opaque phases and some orientation in the sample

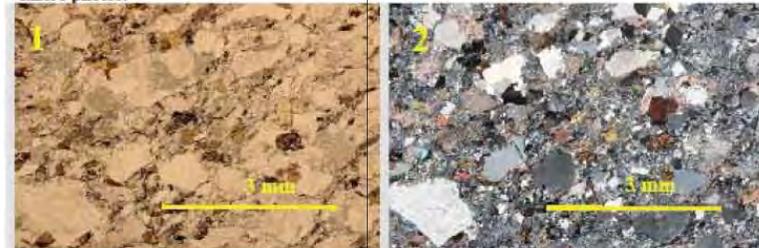
Micro photos of selected area in thin section

1 Ordinary light. Note biotite/chlorite (brown), opaque phases

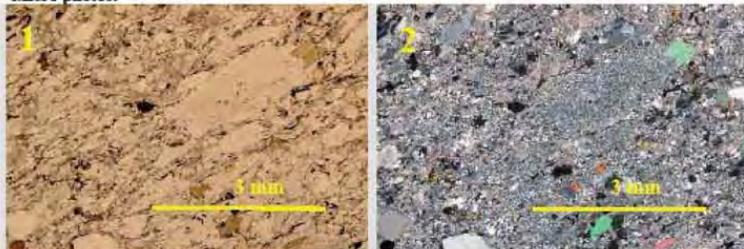
Micro photos of selected area in thin section

1 Ordinary light. Note biotite/chlorite (brown), opaque phases

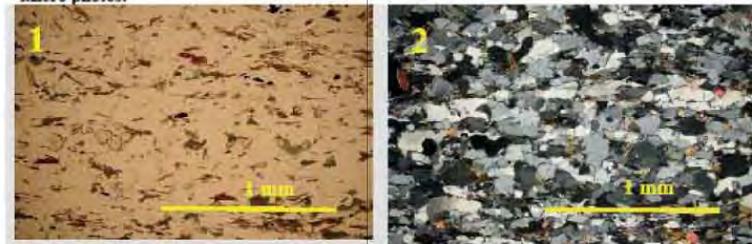
Micro photos of selected area in thin section

1 Ordinary light. Note hornblende and biotite (green-brown) and some orientation in the sample

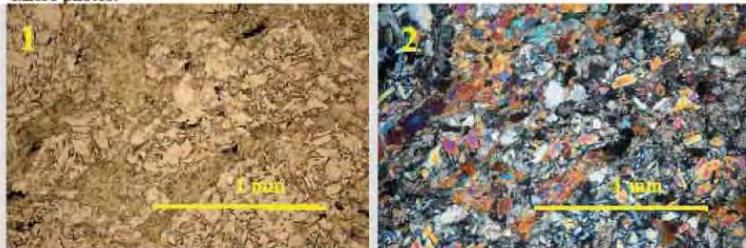
Micro photos of selected area in thin section

1 Ordinary light. Note hornblende (green) and pseudo morph (lighter areas)

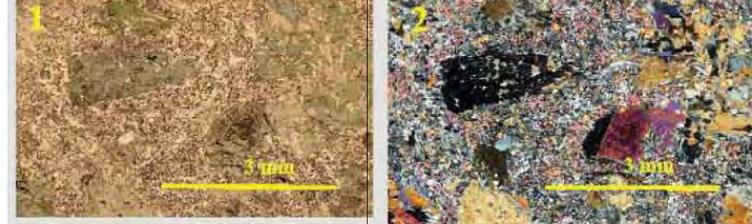
Micro photos of selected area in thin section

1 Ordinary light. Note hornblende (green)

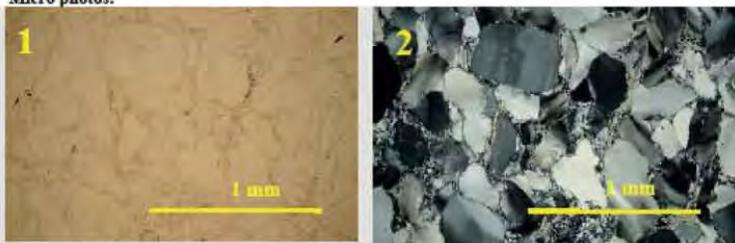
Micro photos of selected area in thin section

1 Ordinary light. Note clastic grains

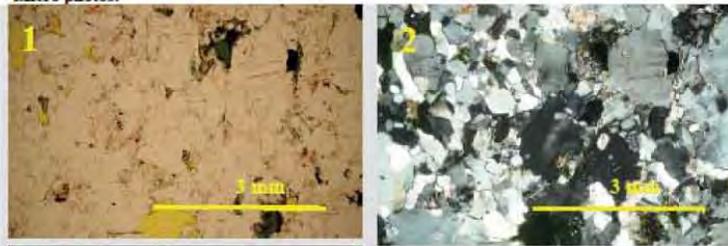
Micro photos of selected area in thin section

1 Ordinary light. Note red coloured hematite
