Detecting Anomalies and Water Distribution in Railway Ballast Using GPR

MASTER'S THESIS

Department of Civil and Transport Engineering
Norwegian University of Science and Technology

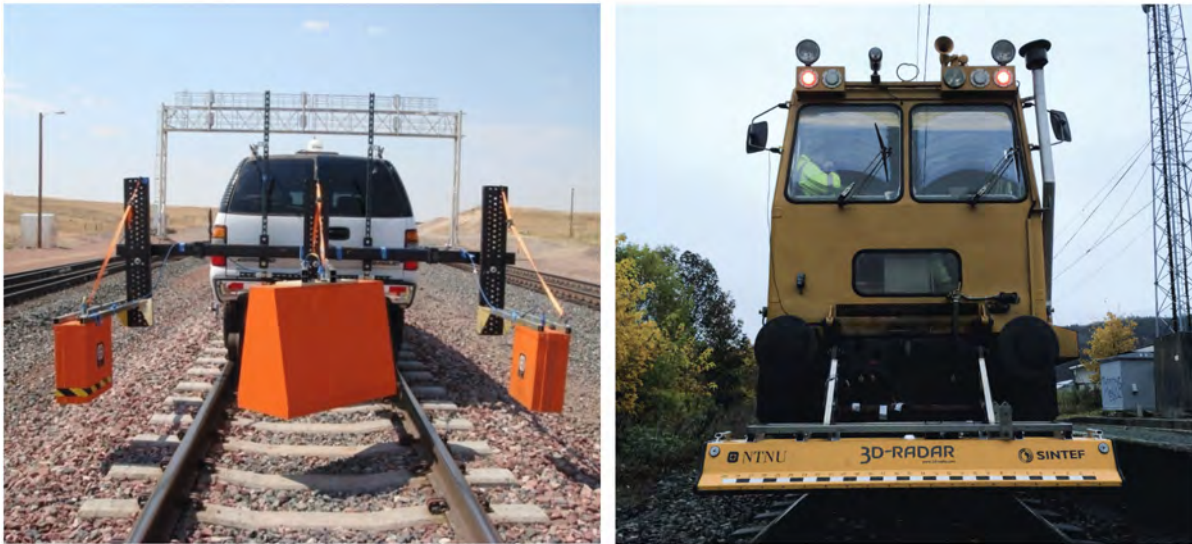
Figure 5: Left: Air-coupled horn-antennas. (Cassidy, 2009) Right: Air-coupled bow-tie antenna array.

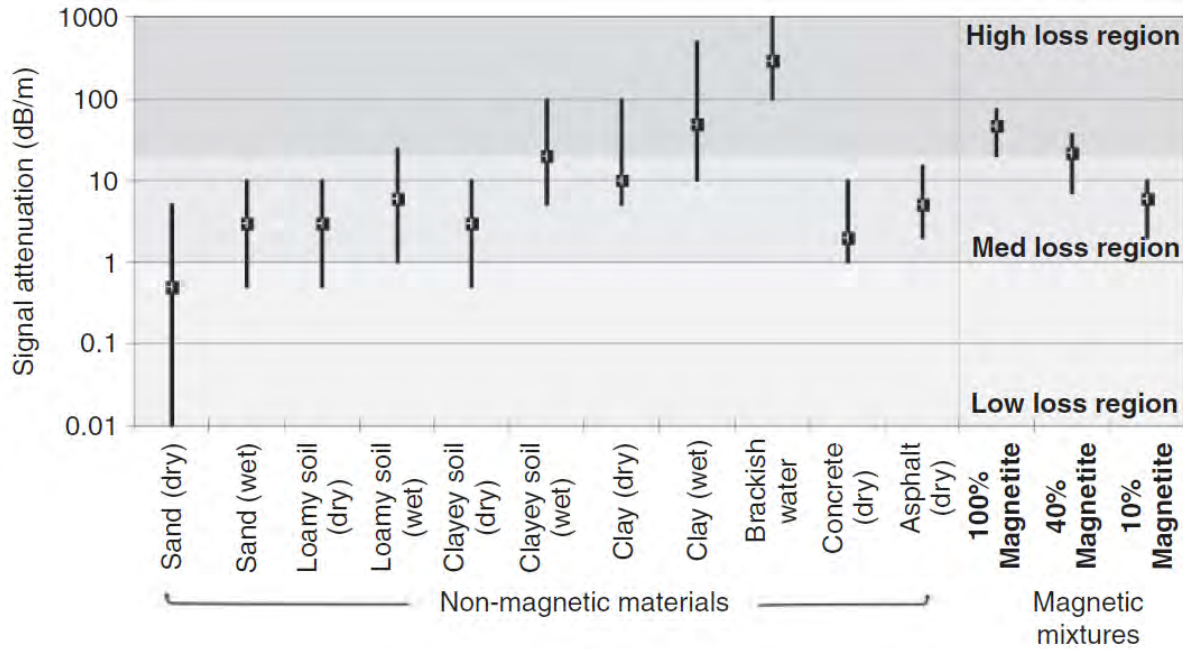
Figure 6: Typical material attenuation values and ranges for common near surface materials. (Cassidy, 2009)

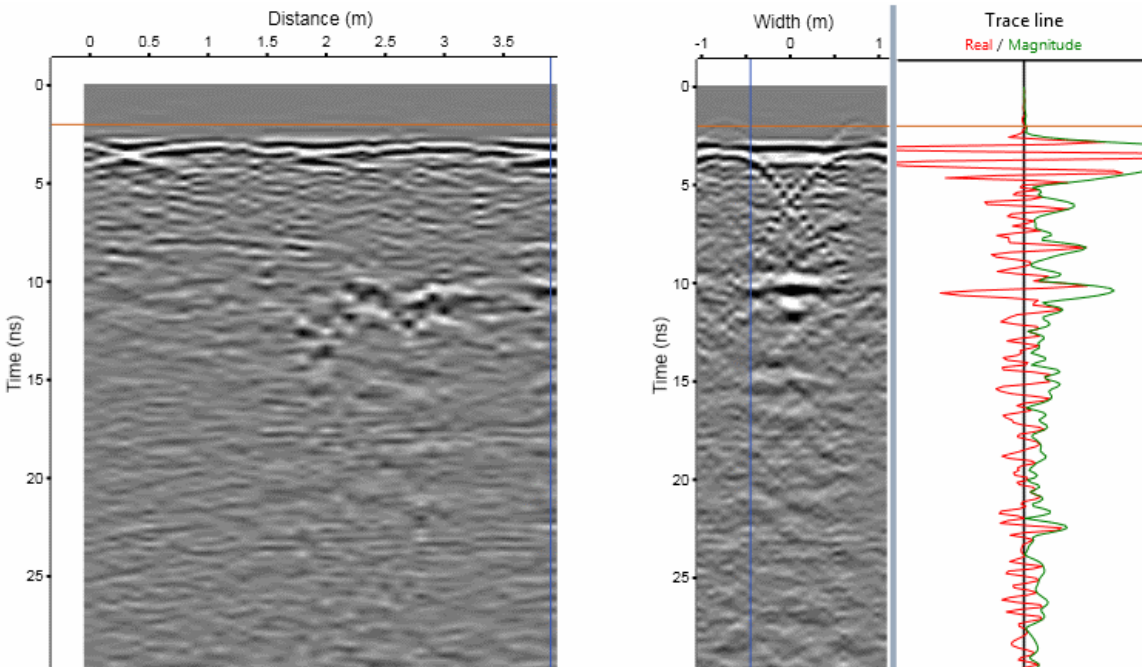
Figure 7: Example of radargram resulting from railway track survey. Left: Longitudinal profile. Right: Lateral profile and signal amplitude response.

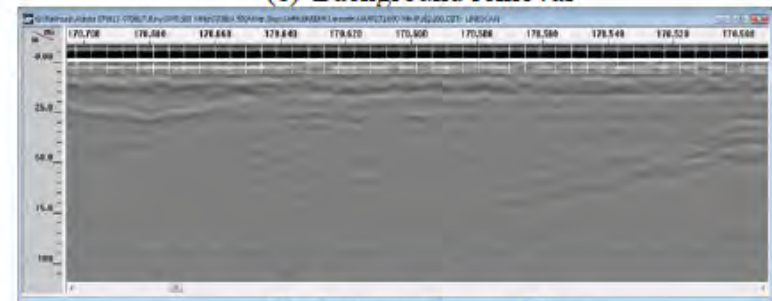
(a) Unprocessed 500 MHz data, 1 scan/ft data density

(b) Time-zero Correction

(c) Background removal

(d) Horizontal smoothing

(e) 0-42 dB 2-Point Gain

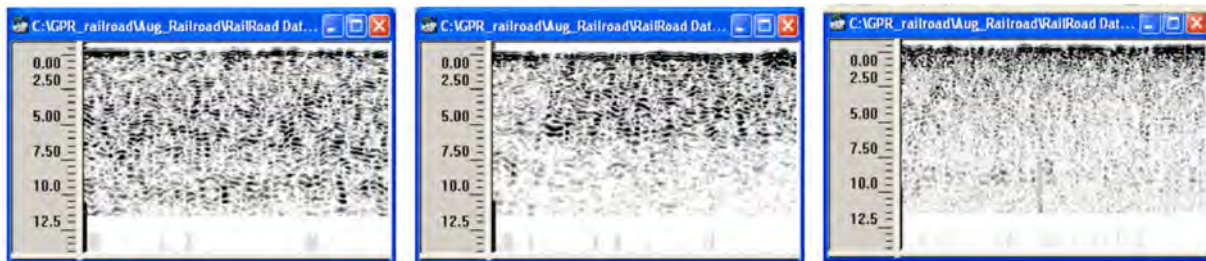
Figure 11: Scattering in radargrams with with different ballast fouling conditions. Left: Clean | Center: Partially fouled | Right: Fouled (Al-Qadi et al., 2008)

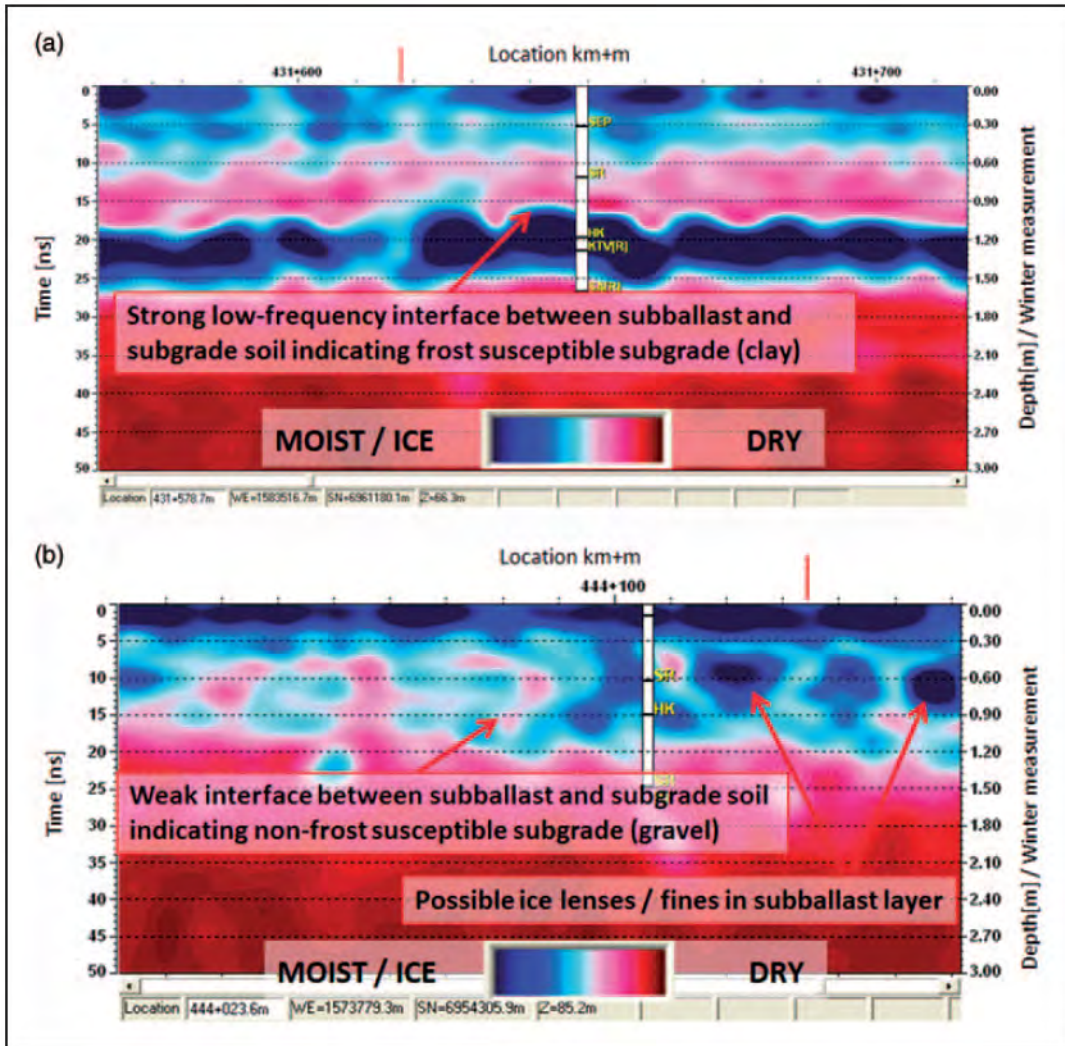
Figure 18: STFT processed GPR scans from: (a) clay subgrade, and (b) coarse gravel subgrade sections. (Silvast et al., 2010b)

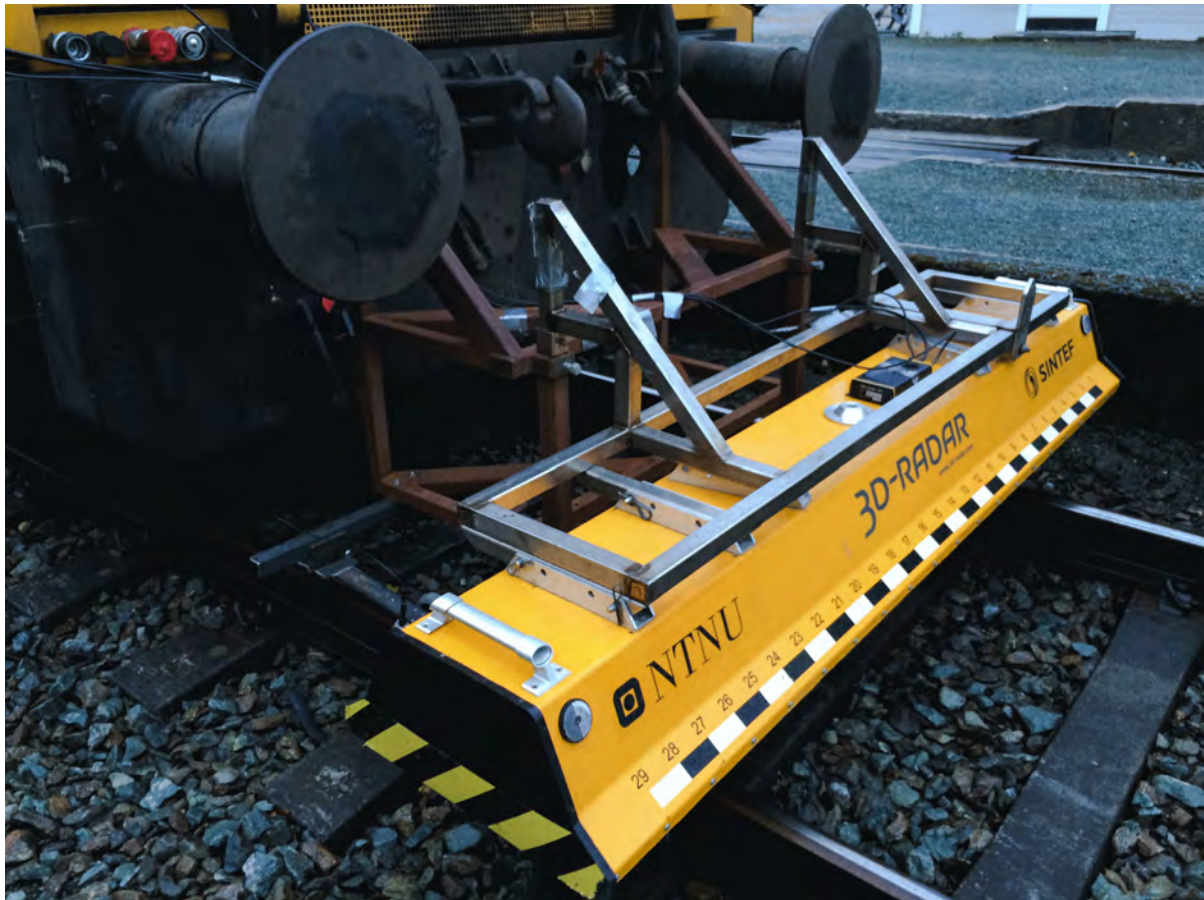
The utilised GPR system was a GeoScope™GS3F system equipped with a V2429 antenna-array from 3d-radar AS, jointly owned by SINTEF and NTNU. The antenna was mounted to a Robel rail tractor supplied and operated by Jernbaneverket for the test.

Figure 20: 3d-radar V2429 antenna-array mounted on Robel rail-tractor

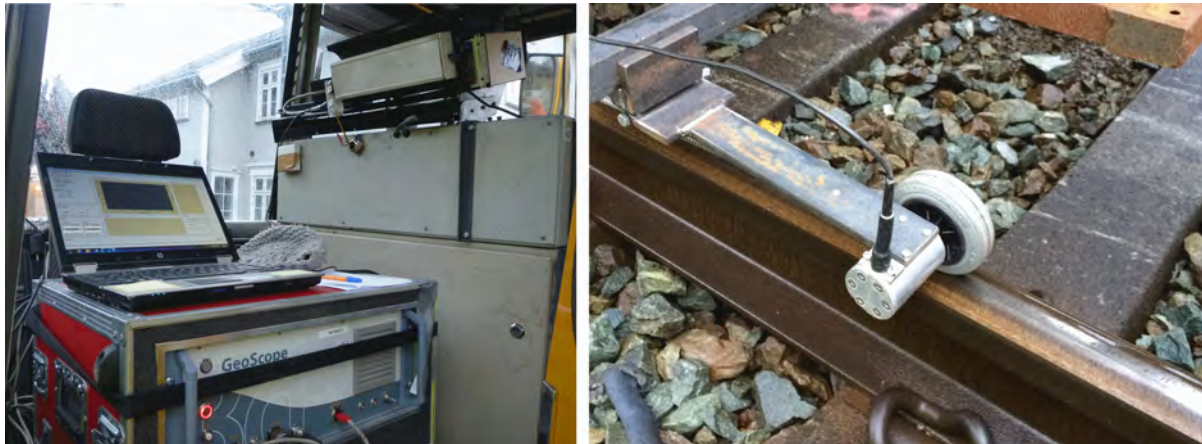
Figure 23: Left: The GeoScope radar unit and operator PC are located in the driver's cabin of the surveying vehicle. Right: Mounted rubber wheel (DMI)

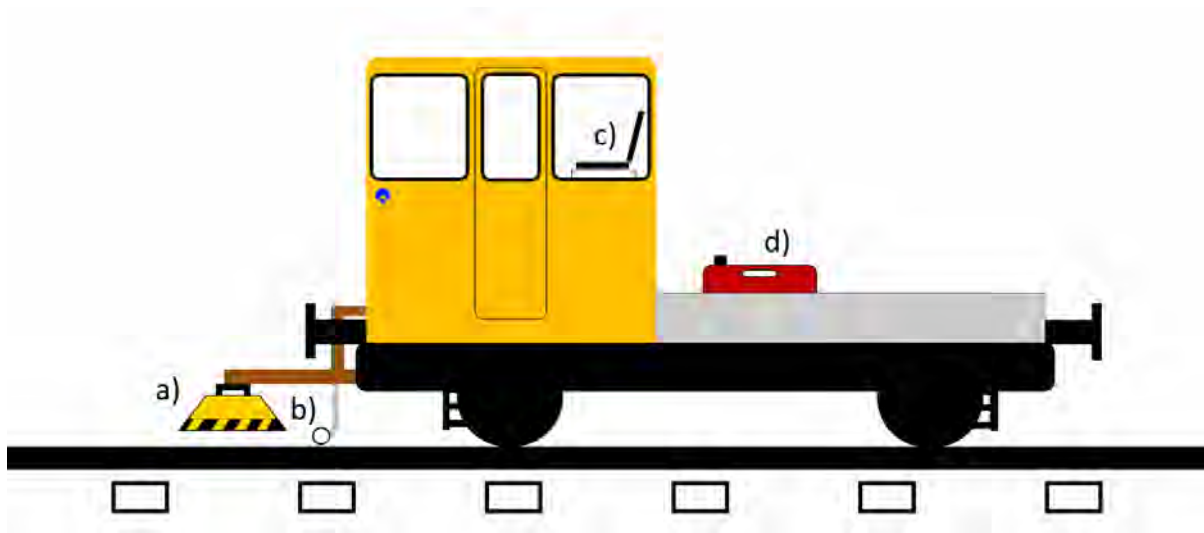
Figure 24: GPR rig schematic for the field survey. a) Antenna array, b) DMI, c) Radar unit and operator PC, d) External power source (generator).

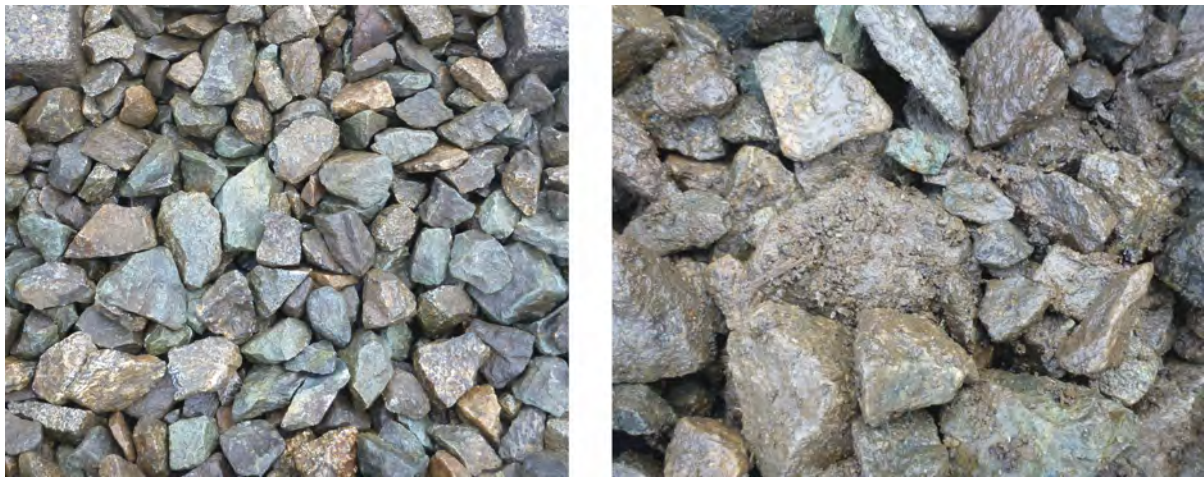
Figure 26: Left: Surface ballast quality. Right: Lightly fouled ballast sample excavated from the same site.

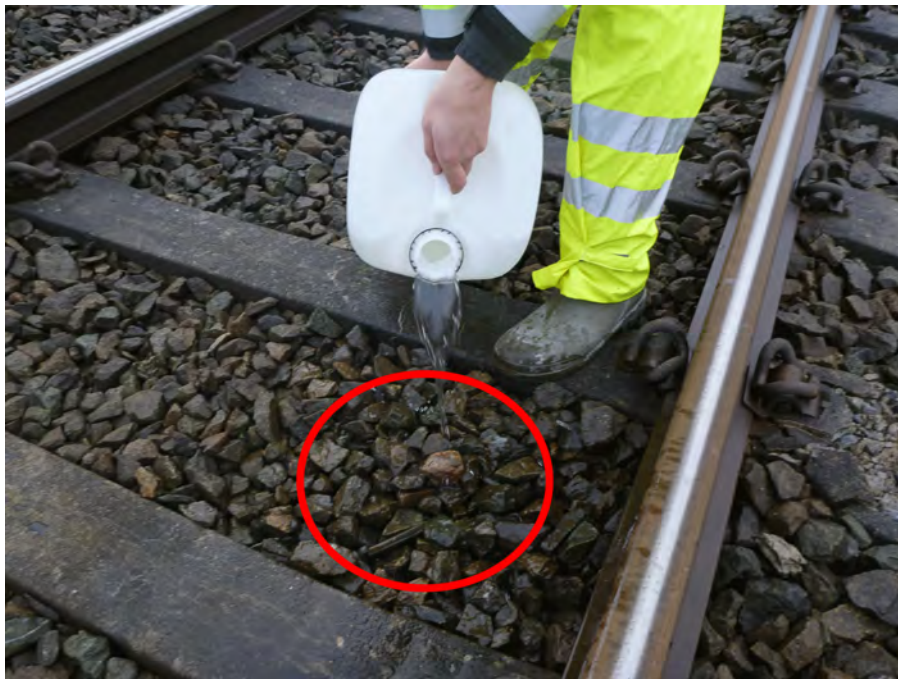
Figure 27: Water being poured into the ballast at the first test site, marked in red.

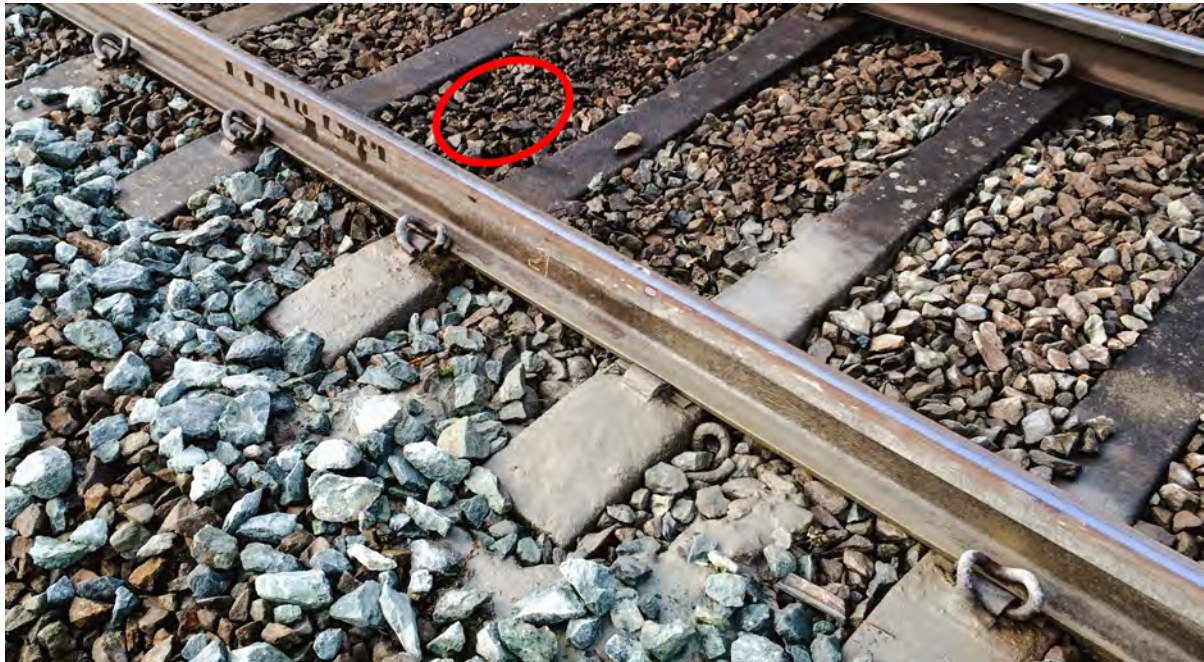
Figure 29: Water test site 2. Fines from mud pumping clearly visible on sleeper ends and adjacent ballast. Water was poured into the area marked in red.

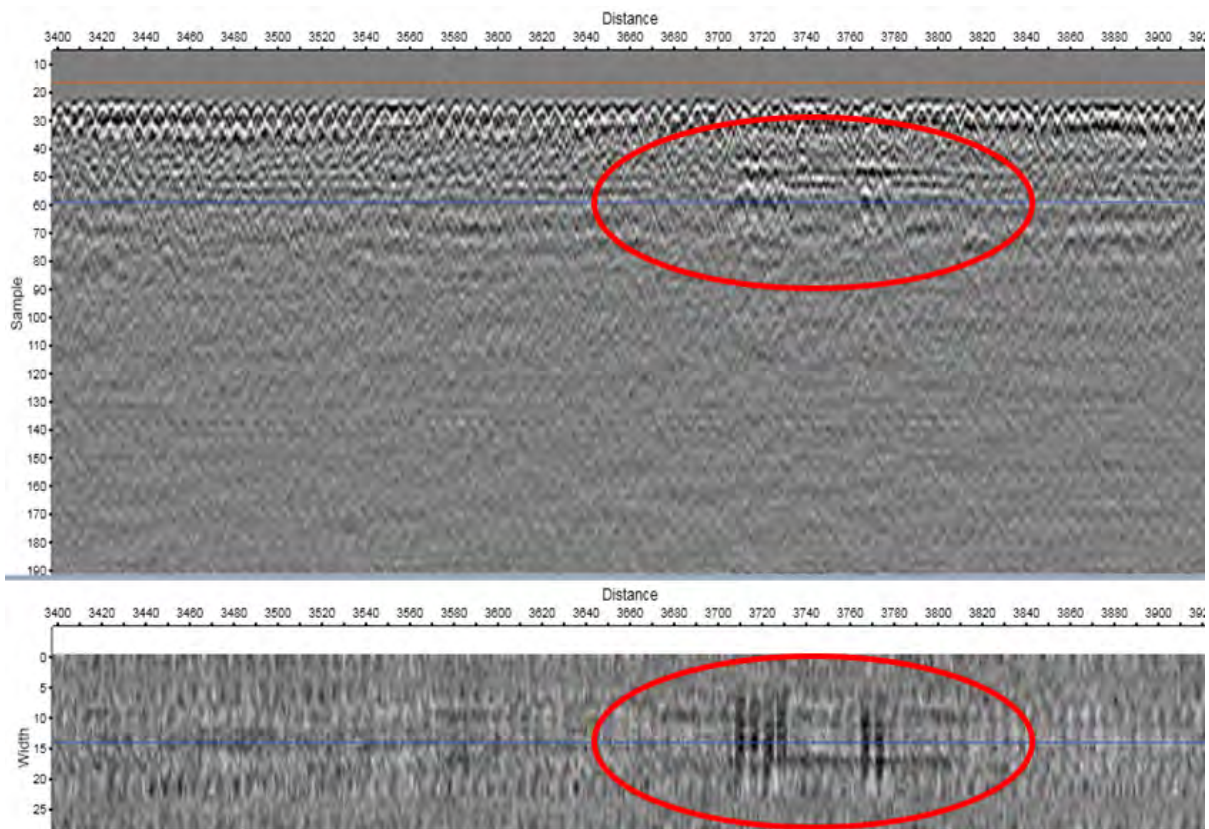
Figure 33: Mud pumping sleepers as shown on the test surveys.

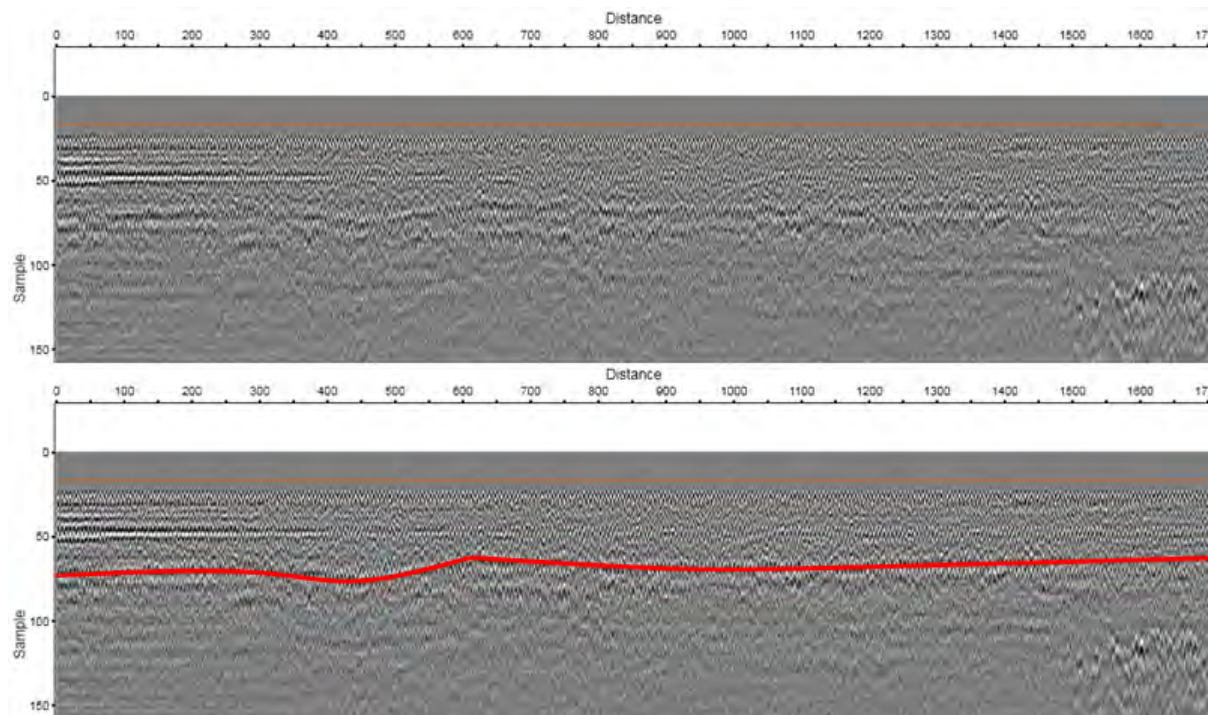
Figure 36: Top: The interface between ballast and subgrade layers as seen on the test survey scans. Bottom: The same image overlaid with a red line to aid interpretation.

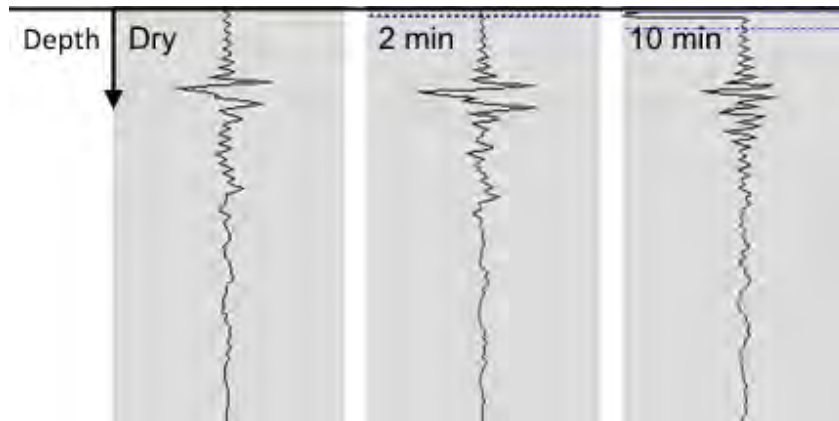
Figure 39: Reflection signal amplitude through the medium at various approximated times after water was poured. Site (a), water distribution test 1. (Image meant for illustration of result. Accuracy of scaling not absolute.)
